# Lake Medina Dam

## Dam Safety Inspection Report

Site Inspections on July 5 and July 6, 2002  
for the

Texas Natural Resource Conservation Commission

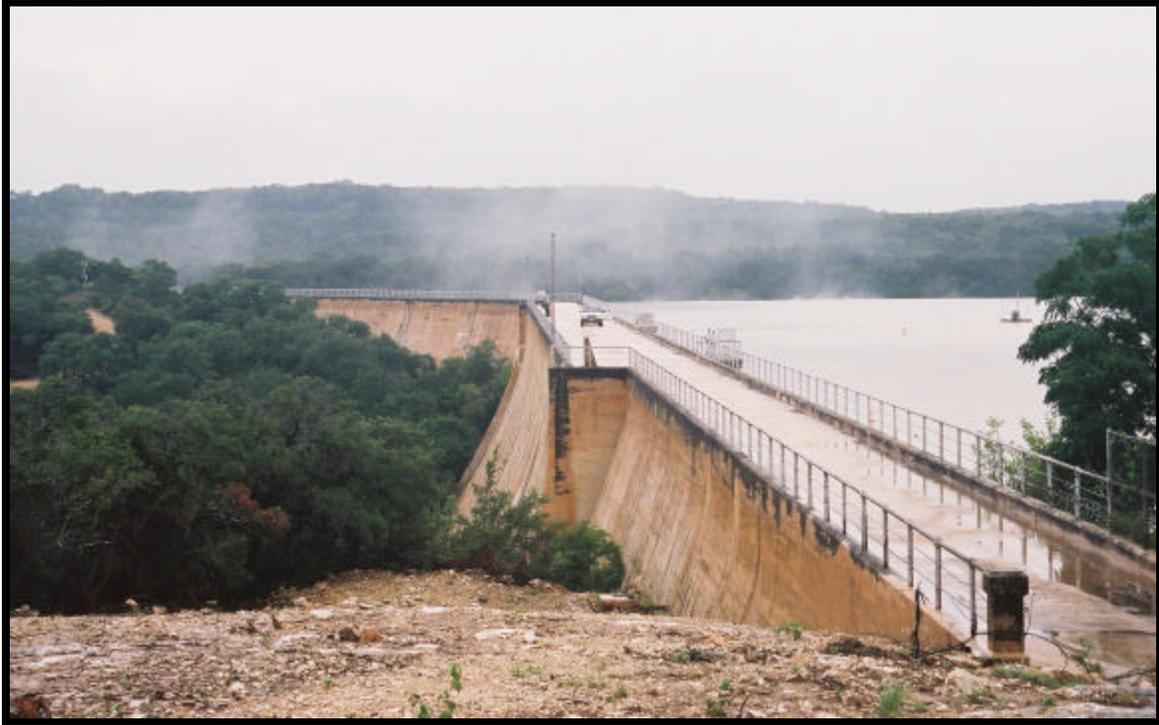
When FNI initially arrived at the left abutment, the access gate was locked. **(Photo 1)** The Bexar-Medina-Attascosa Irrigation District's (BMA) dam tender was on the crest of the dam with a San Antonio news media cameraman (Channel 12). FNI saw no other signs of the news media at or on the dam. The inspection team was able to get a Medina County sheriff deputy, who was patrolling the area, to alert the BMA dam tender to provide access onto the dam. The BMA dam tender (Wayne Solzman) was briefed on the purpose of the inspection (i.e. to perform a dam safety inspection of sufficient degree to determine whether or not there needed to be dam-safety related evacuations below the dam). The Deputy and Mr. Solzman informed us that:

**Photo 1** View of left abutment and crest of concrete gravity section, looking right. (Friday, July 5<sup>th</sup>)

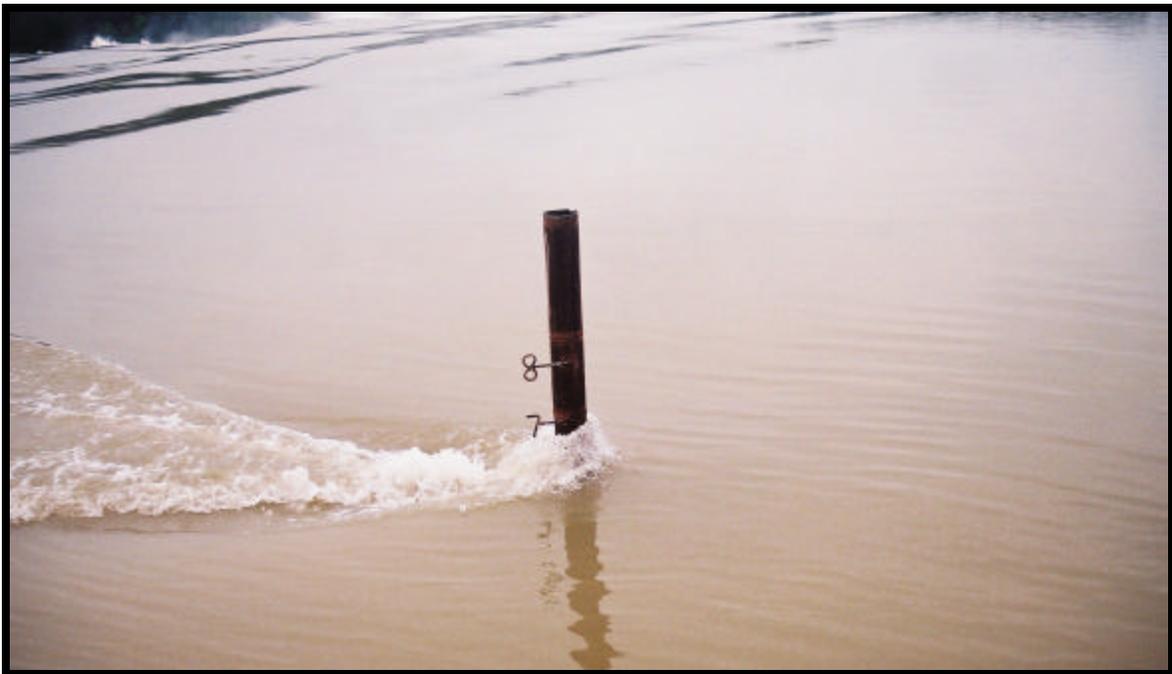
**Photo 2** View of staff gage recording stage height (perhaps over the emergency spillway crest). The gage was located in the drawdown region upstream of the emergency spillway, as evidenced by the accelerated approaching flow and resulting standing wave around the gage. (Friday, July 5<sup>th</sup>)

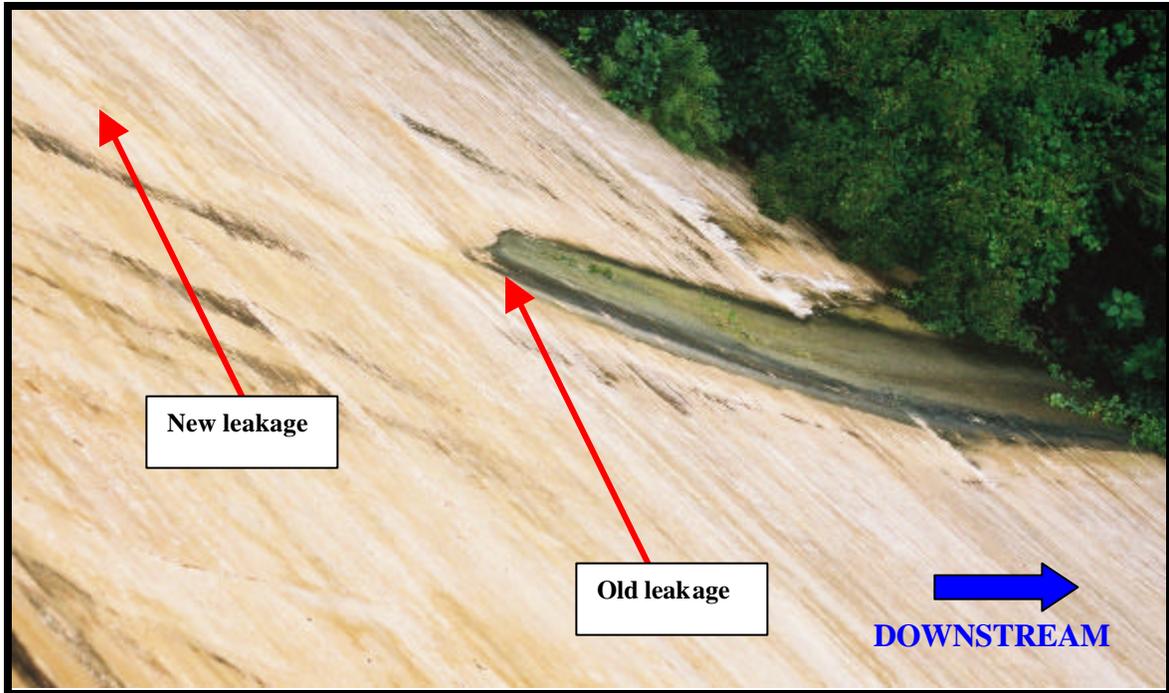
**Photo 3** View of vertical crack in concrete gravity section-left abutment, looking right and downstream. Note the new leakage through the crack versus older, algae-stained leakage areas. (Friday, July 5<sup>th</sup>)

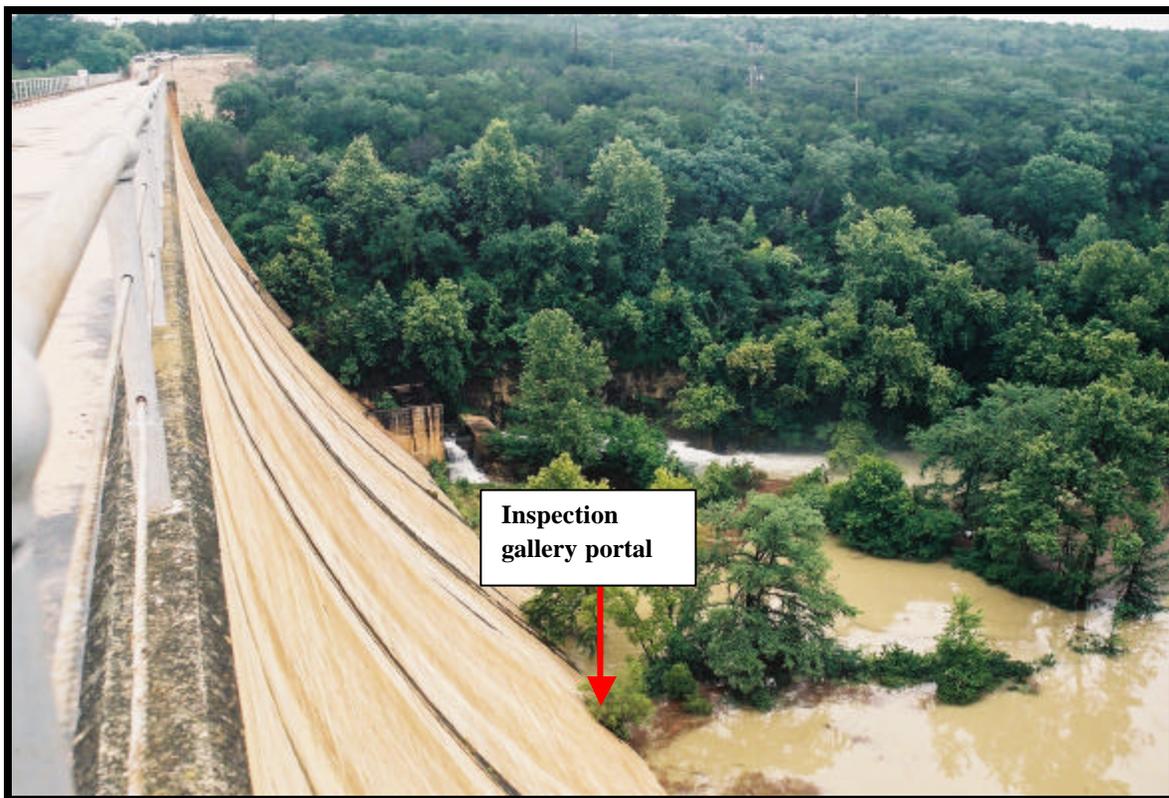
Mr. Solzman later informed us that this section of the dam, which was the tallest section, had a maximum height of about 180 feet. There was minimal tailwater against the toe of the dam. **(Photo 4)** It appeared that the tailwater level was about two (2) feet below the sill of the inspection gallery access portal at the base of the dam. Because of the tailwater inundation, we were not able to see the condition of the foundation rock. We saw no signs of foundation movements or upheavals above tailwater level. From our vantage point, 180 feet above the riverbed, we observed no visible upswells or bubbles rising up through the tailwater along the toe (base) of the dam. The tips of several PVC standpipes were visible above the tailwater.

**Photo 4** View of concrete gravity section-river, looking left and downstream. Note the tailwater level is just below the inspection gallery portal, which is obstructed by vegetation. (Friday, July 5<sup>th</sup>)

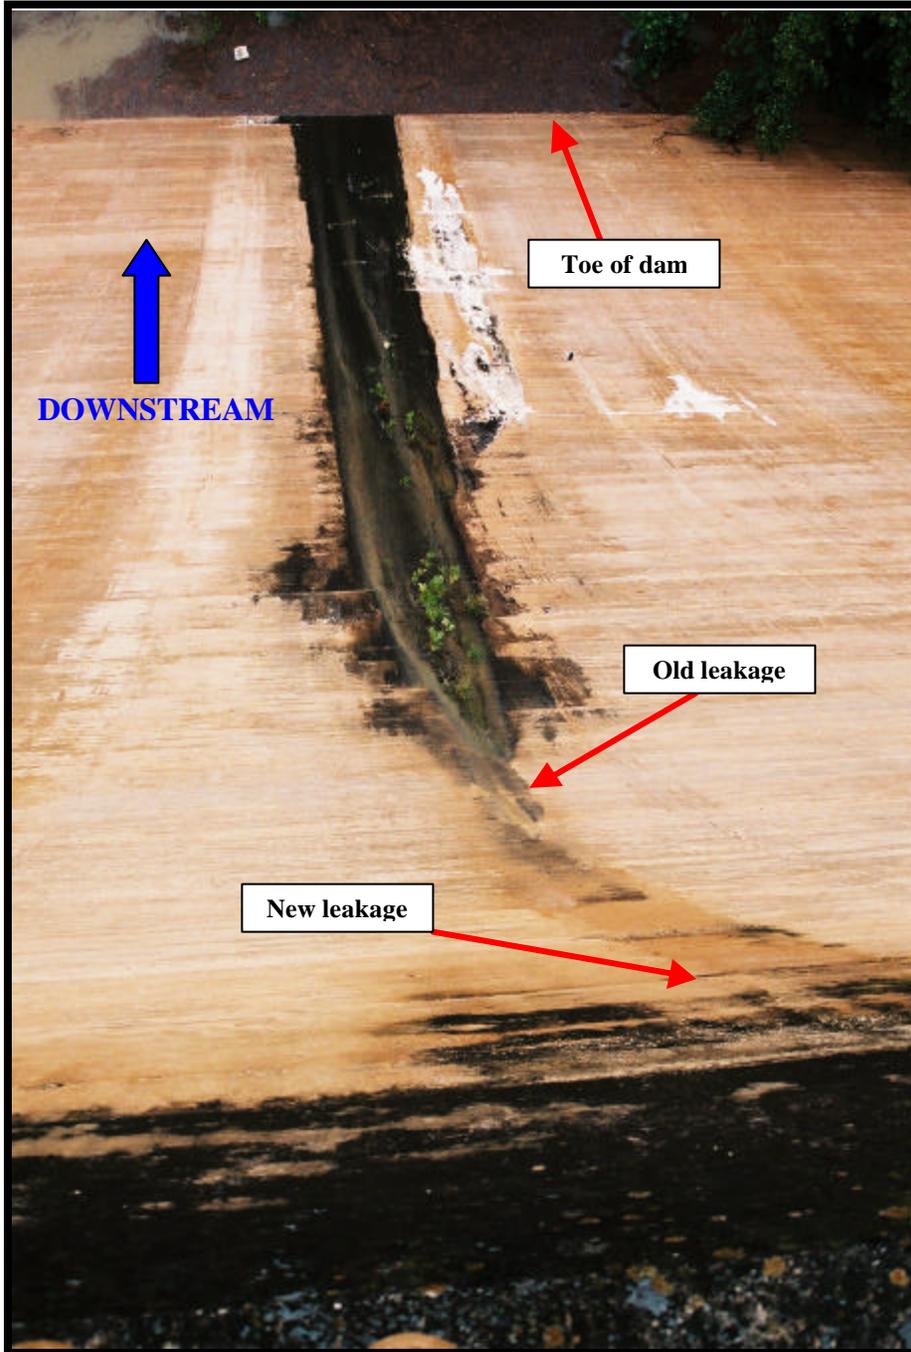
The condition of the mass concrete was much the same as for the concrete gravity section along the left abutment. There were no signs of new cracking, no signs of movements, and no signs of spalling. There were numerous cracks discharging similarly to the cracks we observed in the left abutment section. Two (2) cracks were discharging silt-laden flows. We saw no signs of leakage through the horizontal construction joints. **(Photos 5 and 6)**

**Photo 5** View of a vertical crack in the concrete gravity section-river, looking downstream. Note the new leakage through the crack versus older, algae-stained leakage areas. (Friday, July 5<sup>th</sup>)

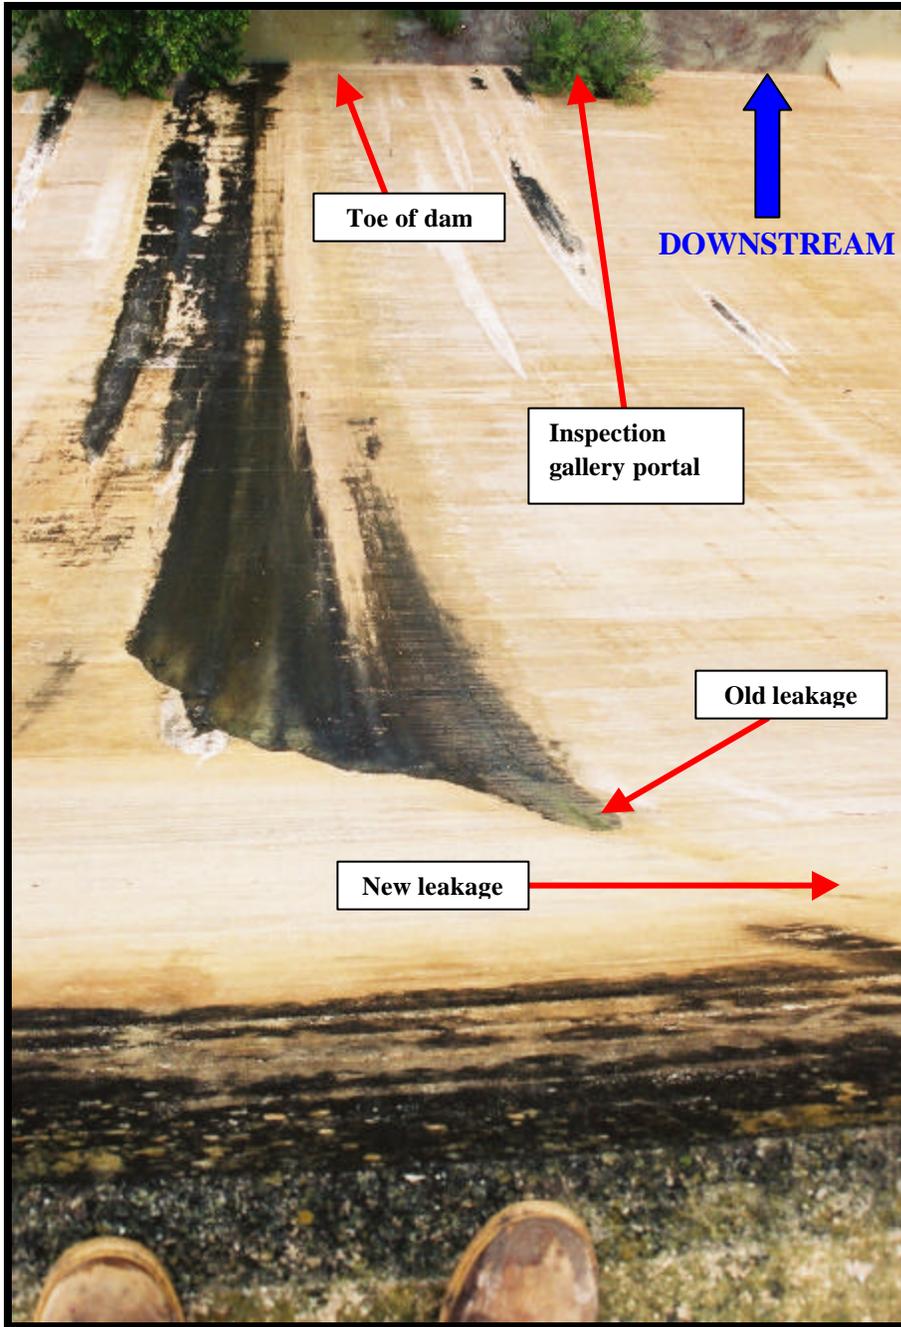
**Photo 6** View of a vertical crack in the concrete gravity section-river, looking downstream. Note the new leakage through the crack versus older, algae-stained leakage areas. (Friday, July 5<sup>th</sup>)

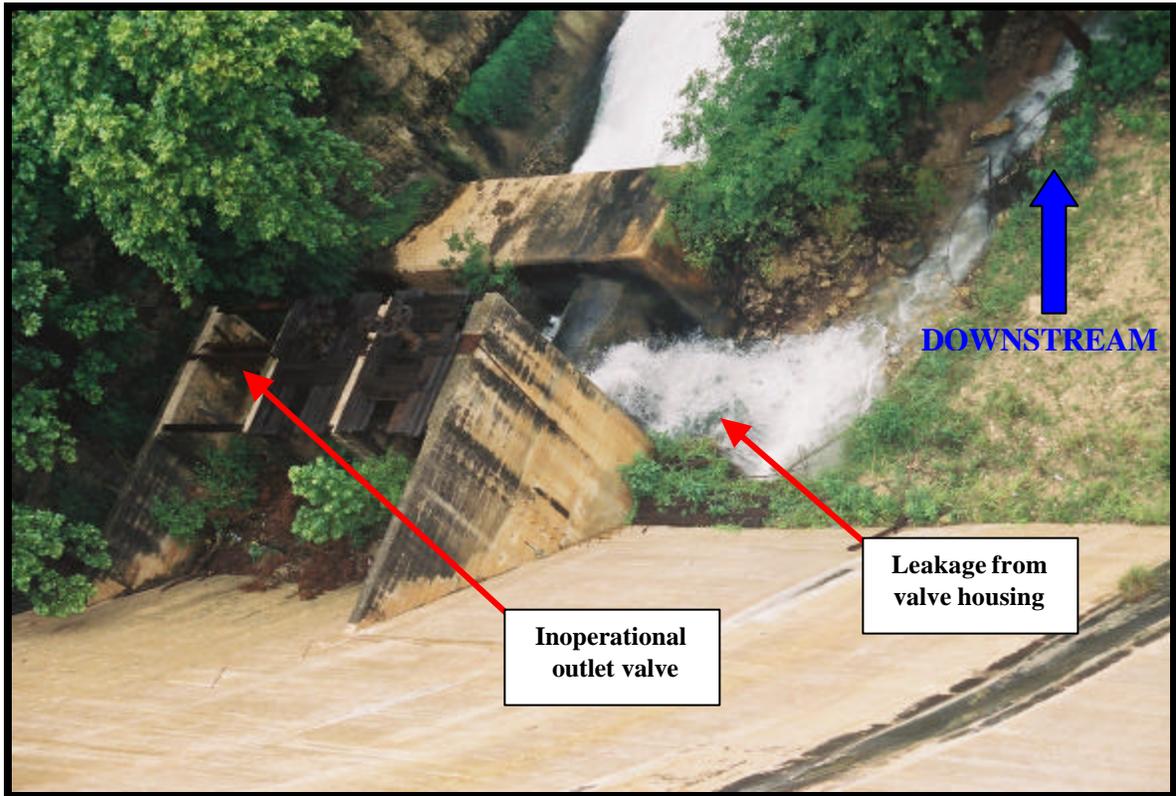
Two (2) of the three (3) outlet works were discharging. We do not know the rate of discharge. Mr. Solzman later informed us that the valve on the third (left-most) outlet pipe was not operational. We observed considerable leakage coming out of the side of the valve housing of the right-most outlet. **(Photo 7)** Mr. Vo (TNRCC) informed us that he was currently reviewing BMA engineering plans to rehabilitate the outlet works. From our vantage point, 180 feet above the riverbed and outlet works, we saw no signs of distress in the valves that would have indicated pending valve failure. We were not able to observe the condition of the concrete flume below the valves or the river channel immediately below the flume's termination because of the turbulence and depth of the outlet works' discharge.

**Photo 7** View of outlet works at the left end of the concrete gravity section-river, looking left and downstream. Note the valve on the right is discharging uncontrolled flow out the side of the valve housing. (Friday, July 5<sup>th</sup>)

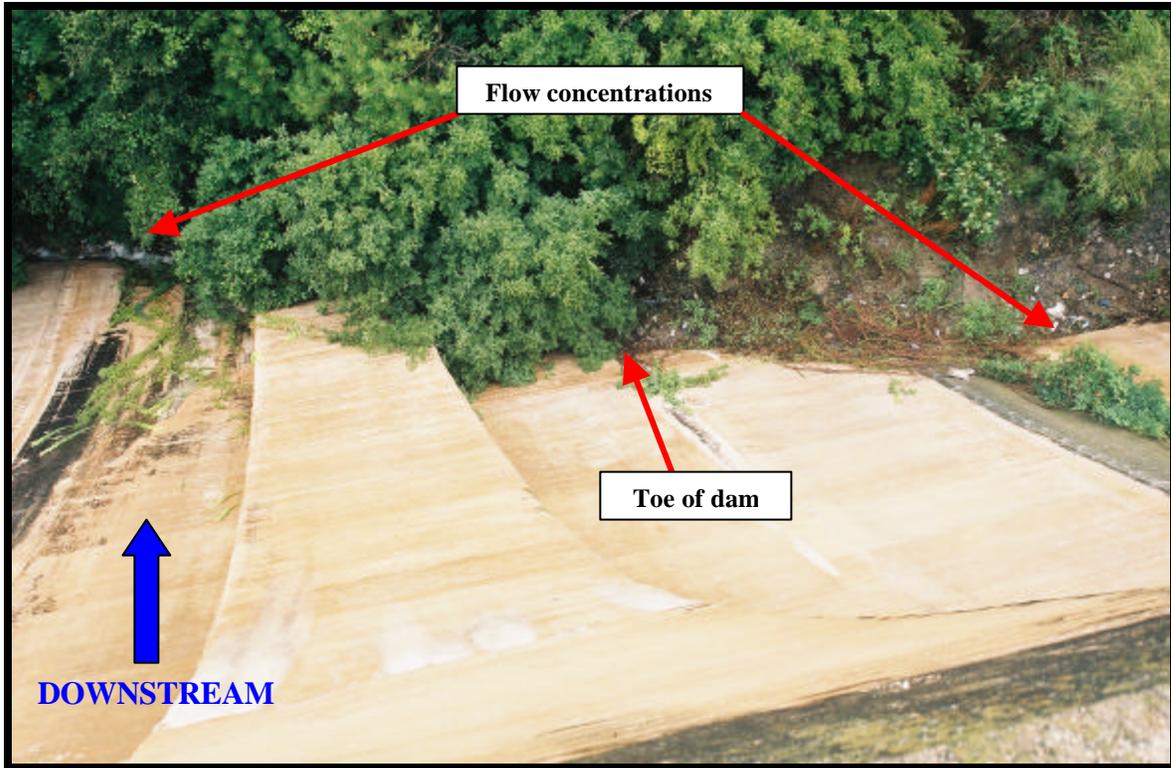
The heavy overgrowth along the immediate toe of the dam made it difficult to observe the foundation and seepage conditions along the right abutment section. We were able to observe that there was a much greater (visible) accumulated flow along the toe (base) of the dam along this section, as compared to the accumulated flow along the left abutment section. **(Photo 8)** We also observed a concentrated discharge coming from an exposed rock formation about 10 feet downstream of the toe of the dam, near the junction of the right abutment section with the river section. **(Photo 9)** From our vantage point on the crest, the concentrated discharge appeared to be clear. There were no signs of accumulated flows of this magnitude above this rock outcropping, and the magnitude of the discharges from the vertical cracks above the outcropping did not account for the rate of discharge from the outcropping. There were no visible signs of foundation movements around the discharge area (however, the heavy undergrowth and trees obstructed the view of practically all of the foundation area below the dam).

**Photo 8** View of accumulated flow along toe of concrete gravity section-right abutment, looking downstream. (Friday, July 5<sup>th</sup>)

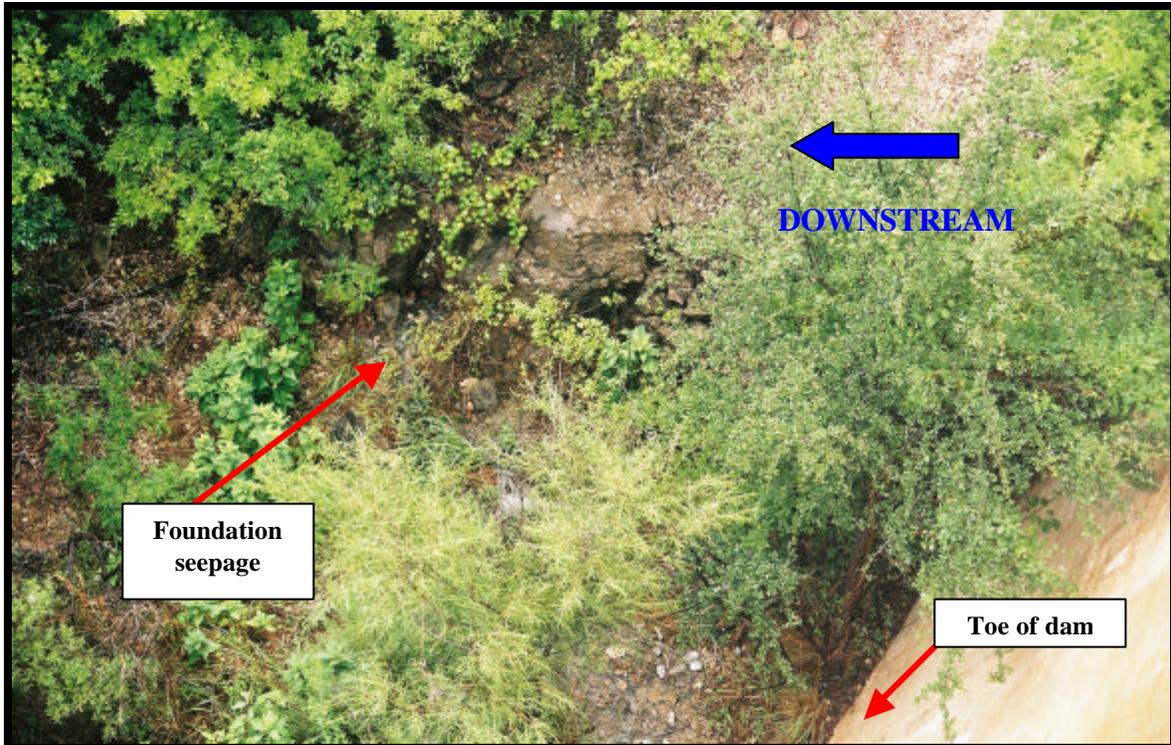
3. The concentrated seepage discharges from the rock outcropping adjacent to the most significant vertical crack in the right abutment's concrete gravity section indicated a pressurized foundation zone, with an uplift that might be approaching straight-line uplift.

**Photo 9** View of foundation seepage downstream of toe of dam, looking right and downstream. (Friday, July 5<sup>th</sup>)

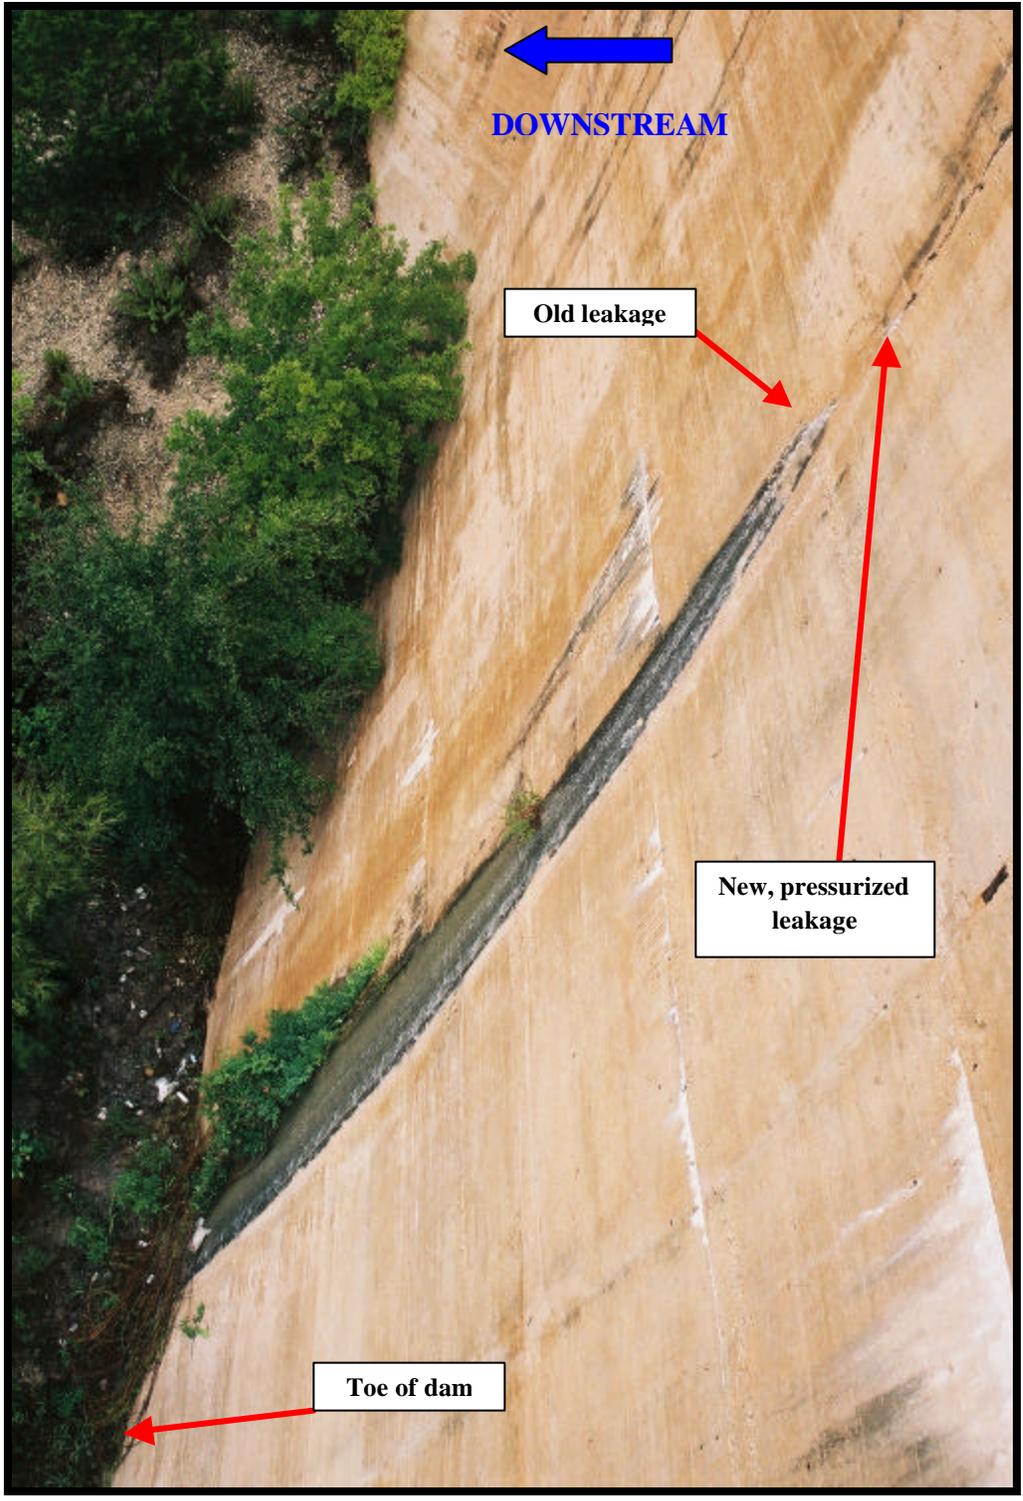
In general, the visible condition of the right abutment's concrete gravity section was the same as the condition of the left abutment's concrete gravity section. There were no signs of new cracking, no signs of movements, and no signs of spalling. One (1) vertical crack near the junction of the right abutment section with the river section (almost in line with the concentrated discharge from the rock outcropping) was a much more "jagged" crack than any of the other observed cracks, and was discharging at much higher rates (between 50 to 100 gpm). **(Photos 10 and 11)**

**Photo 10** View of vertical crack in concrete gravity section-right abutment, looking right. Note the pressurized leakage exiting the crack several feet above the old, algae-stained leakage area. (Friday, July 5<sup>th</sup>)

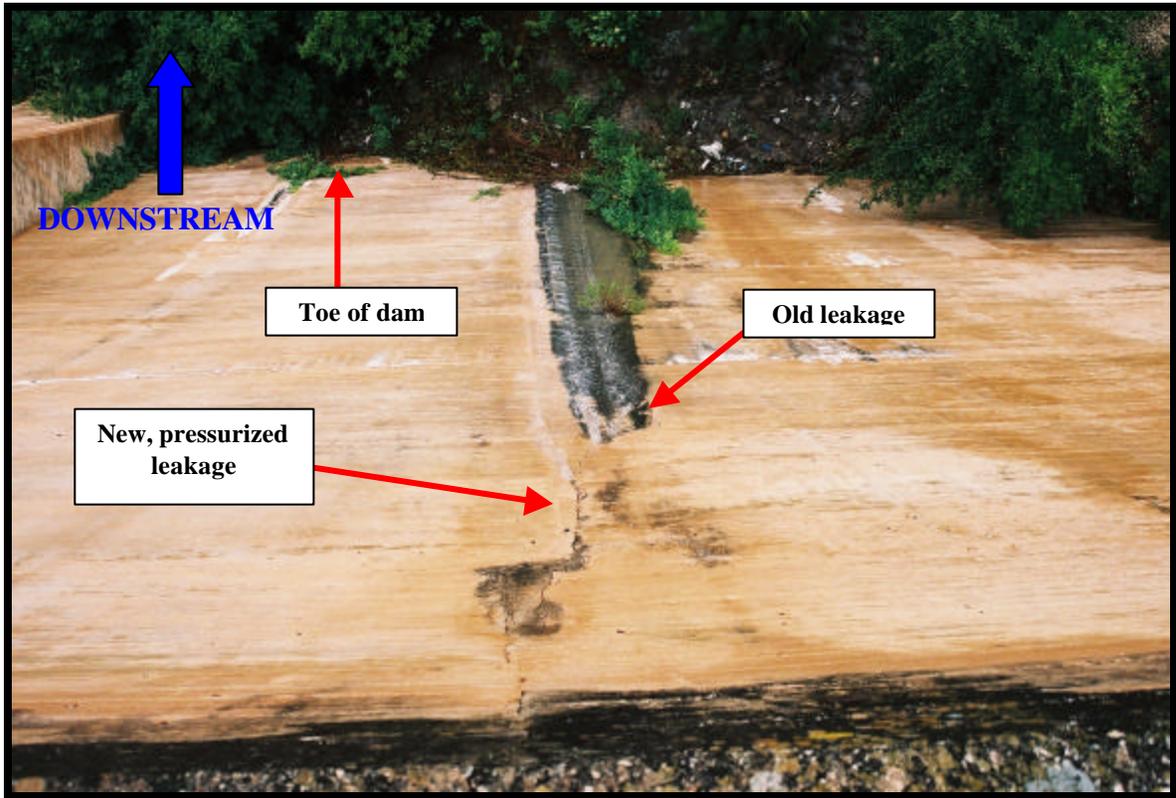
**Photo 11** View of vertical crack in concrete gravity section-right abutment, looking downstream. Note the pressurized leakage exiting the crack several feet above the old, algae-stained leakage area. (Friday, July 5<sup>th</sup>)

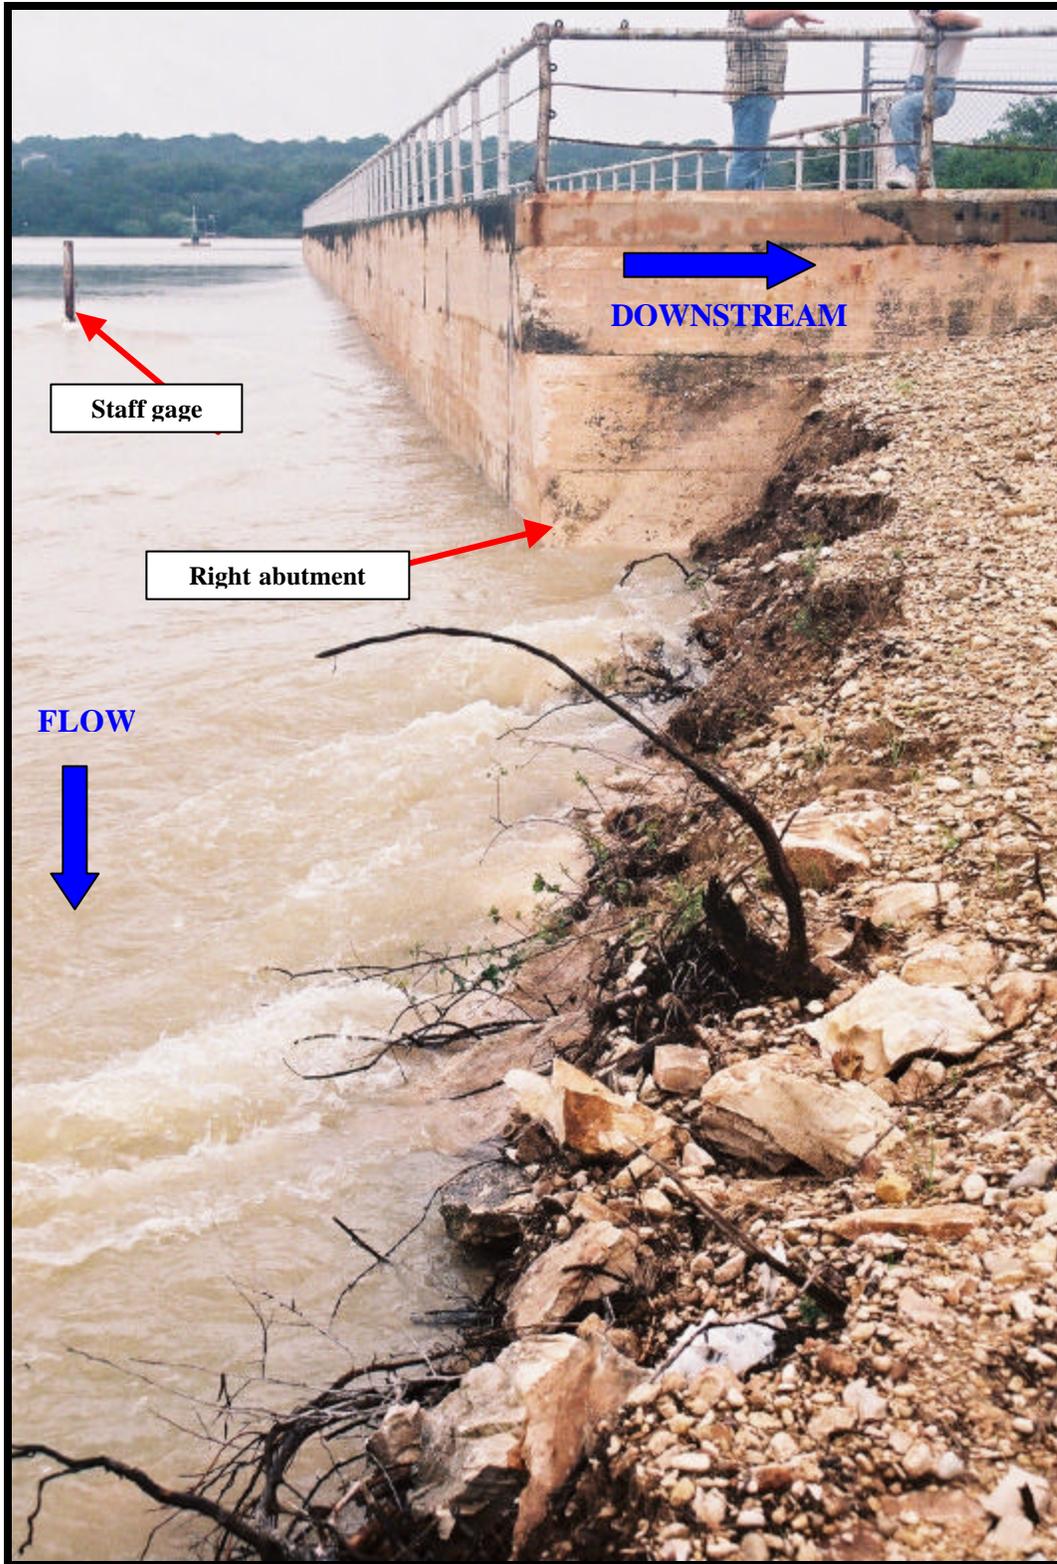
There was active erosion occurring along the immediate right end of the right abutment. **(Photo 12)** It appeared that the left bank and the crest of the emergency spillway channel were very close to the end of the right abutment gravity section. In order for flows to enter the emergency spillway channel, the flow direction had to take almost a 90° turn to the right. The "outside bend" of the current was sweeping along the upstream face of the end of the right gravity section, and then accelerating to supercritical flow at the "lip" of the control section behind the end of the gravity section. **(Photo 13)** There were standing waves along the upstream face of the gravity section and along the periphery of the flows behind the end of the gravity section. **(Photo 14)** The accelerating flows and standing waves were actively eroding the fill encapsulating the end of the gravity section. Mr. Solzman informed us that the BMA had recently constructed an access road around the end of the dam to provide access into and across the emergency spillway channel. It appeared to Mr. Solzman that the erosion was occurring within this access road fill. There was less than a 50-foot wide area of this actively eroding fill preventing the accelerated emergency spillway flows from flanking the right abutment of the dam.

4. The erosion around the immediate right end of the right abutment's concrete gravity section posed a high risk of breaching the right abutment, if the erosion remained unchecked. A release of floodwaters through the breach section along the downstream toe of the right abutment, could then very likely initiate a failure in the right abutment's concrete gravity section.

**Photo 12** View of erosion along right abutment, looking left. Note the standing waves along the abutment. (Friday, July 5<sup>th</sup>)

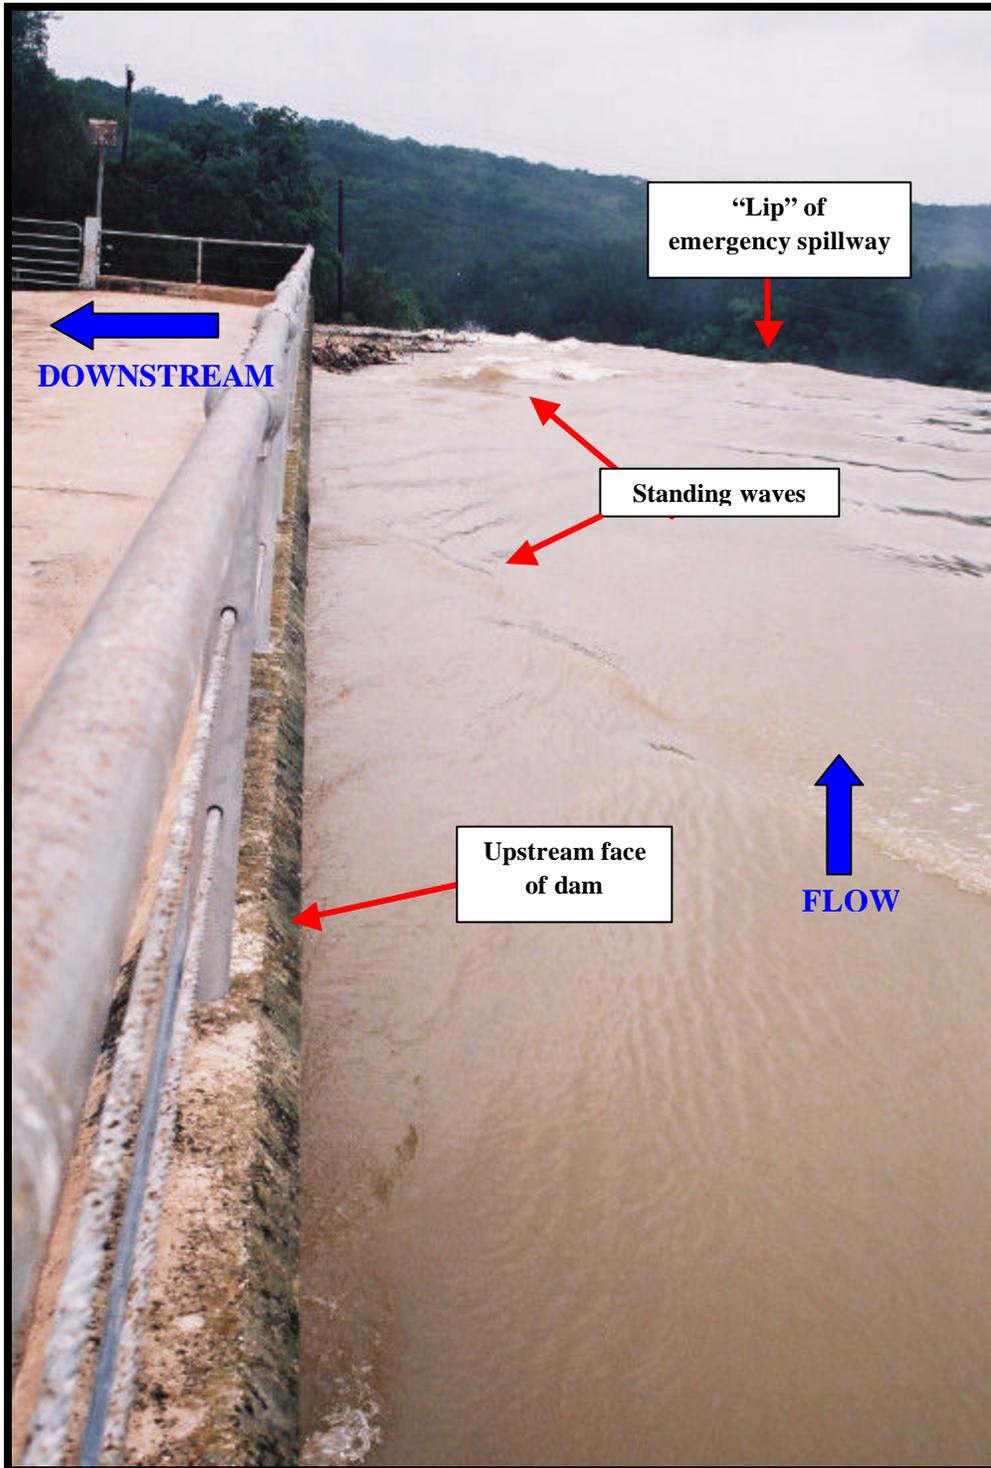
In addition to the erosion at the immediate end of the gravity section, the emergency spillway flows were overtopping its left overbank, beginning at the end of the gravity section, and overland flows were fanning out behind and downstream from the right end of the dam. **(Photo 15)** The "lip" of the emergency spillway channel was about 150 to 200 feet at its closest point downstream and behind the right end of the concrete gravity section. **(Photos 13 and 14)**

**Photo 13** View of right abutment, looking right. Note the erosion along the abutment (see Photo 12) in the background. (Friday, July 5<sup>th</sup>)

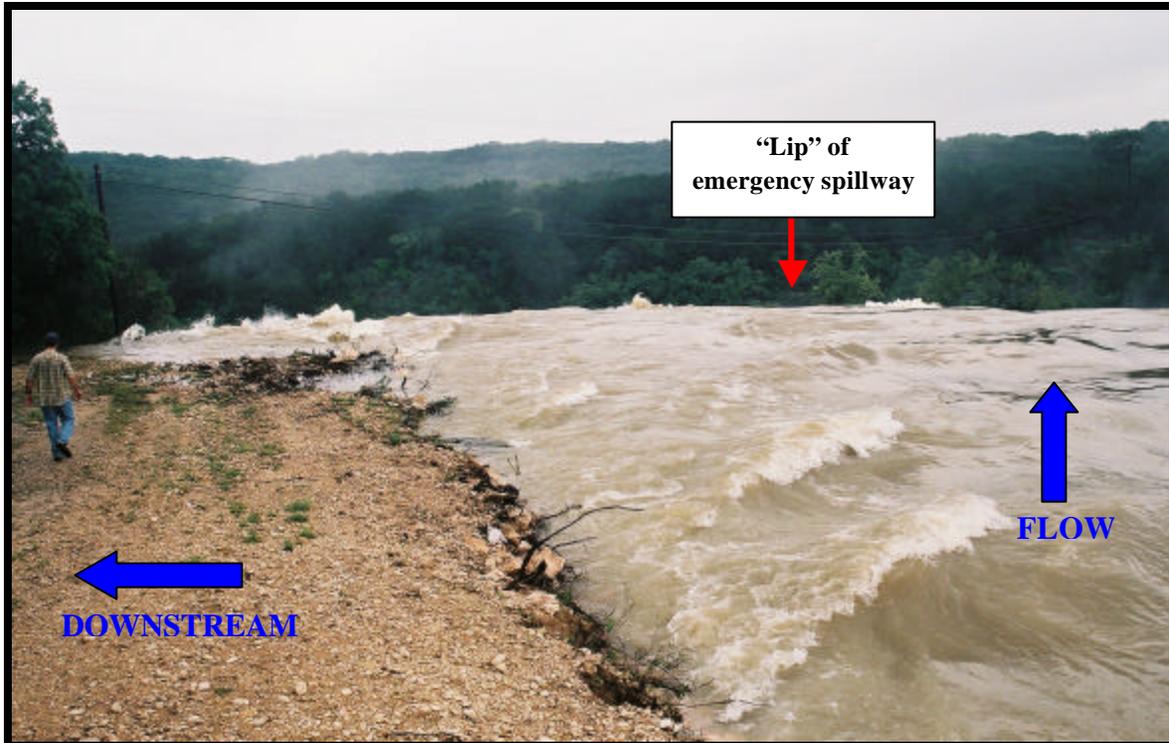
**Photo 14** View of erosion along right abutment, looking right. Note the standing waves along the abutment. (Friday, July 5<sup>th</sup>)

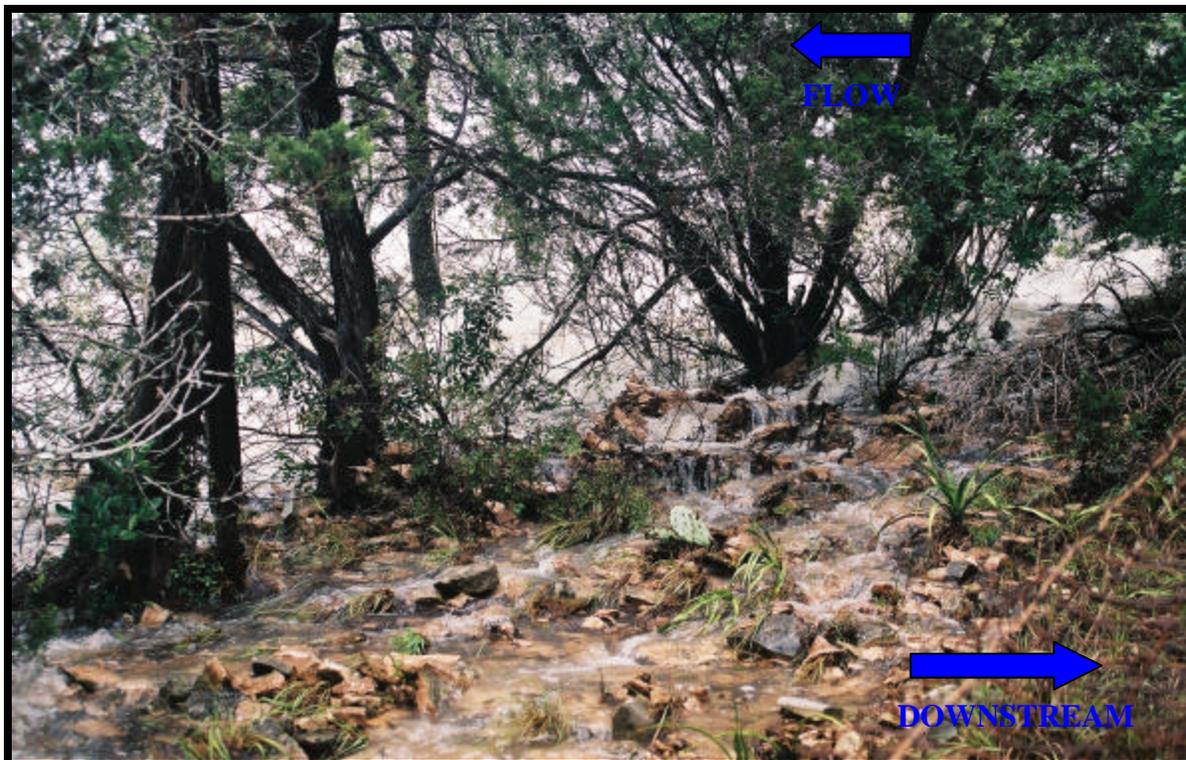
**Photo 15** View of overtopping and erosion of left overbank, looking left. (Friday, July 5<sup>th</sup>)

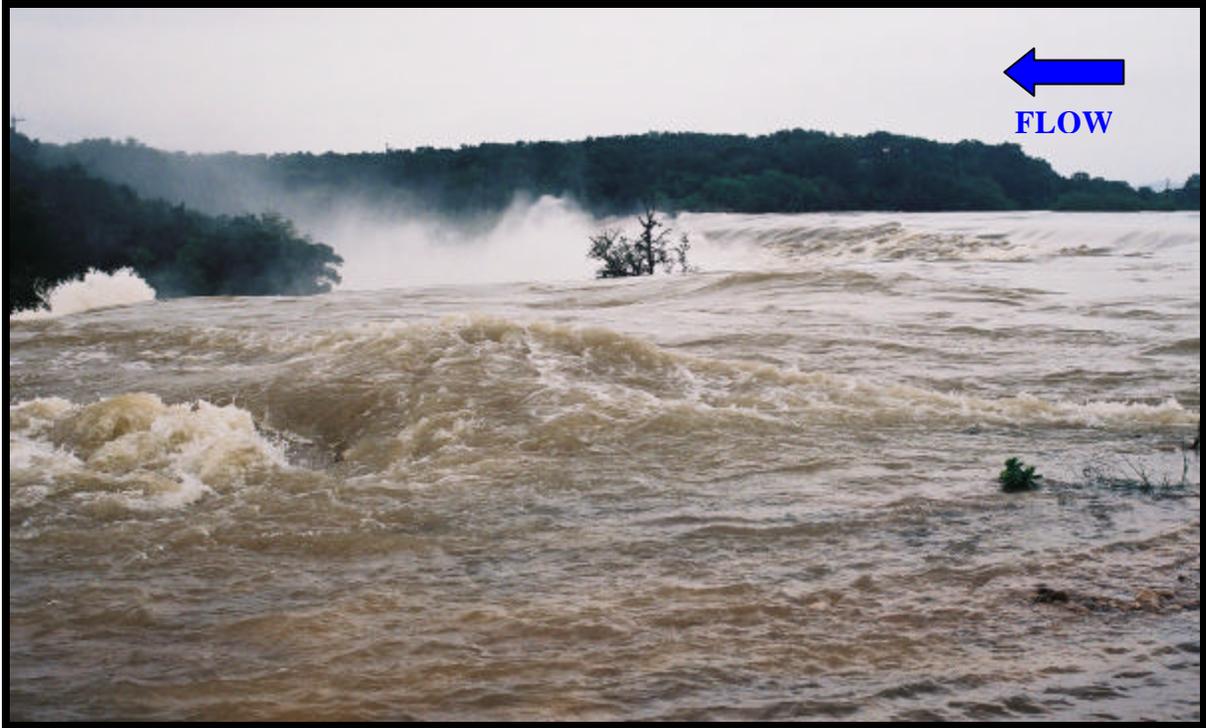
**Photo 16** View of discharge over emergency spillway, looking upstream from the right abutment. Note the turbulent flow and standing waves approaching the spillway “lip”. (Friday, July 5<sup>th</sup>)

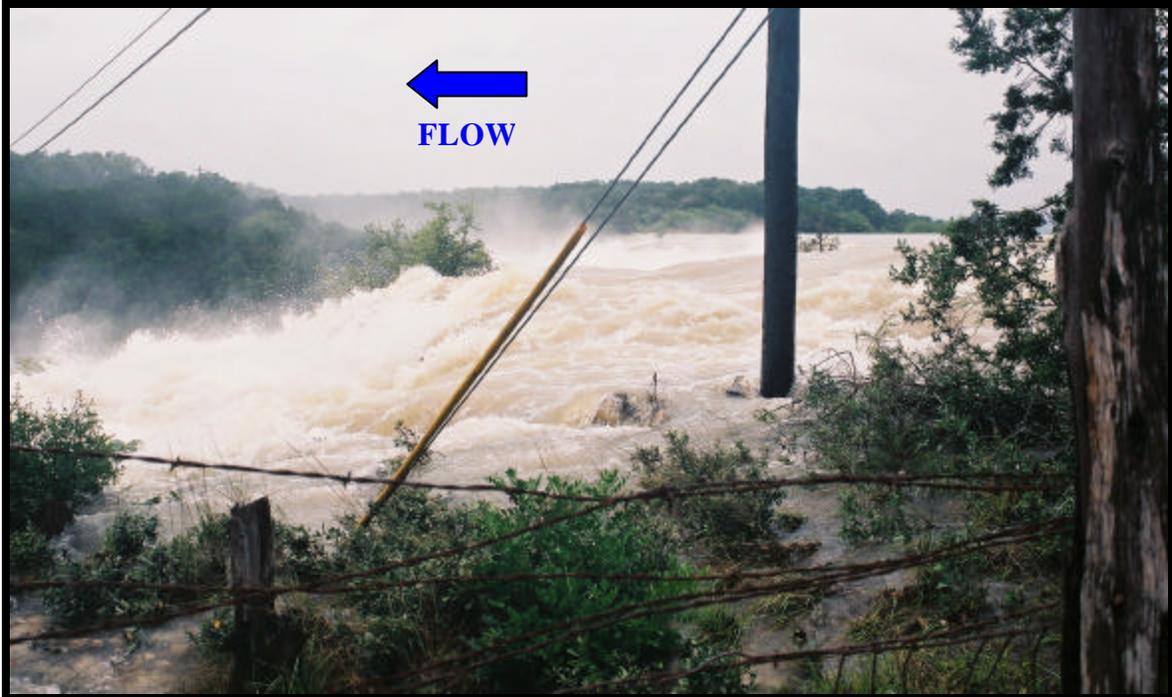
**Photo 17** View of discharge over emergency spillway, looking upstream from the left overbank. Note the overtopping of the left overbank in the foreground. (Friday, July 5<sup>th</sup>)

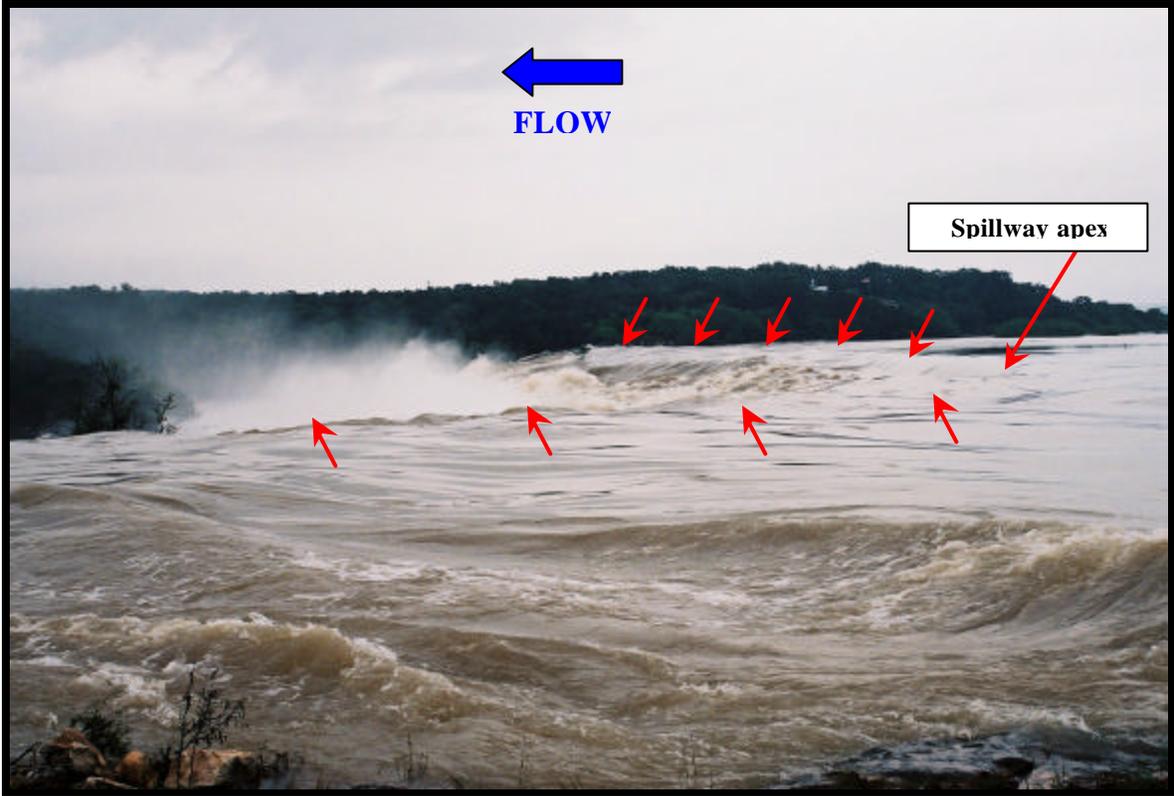
**Photo 18** View of the emergency spillway, looking upstream from the right abutment. Note the concave alignment of the spillway lip and its apex at the near the midpoint. (Friday, July 5<sup>th</sup>)

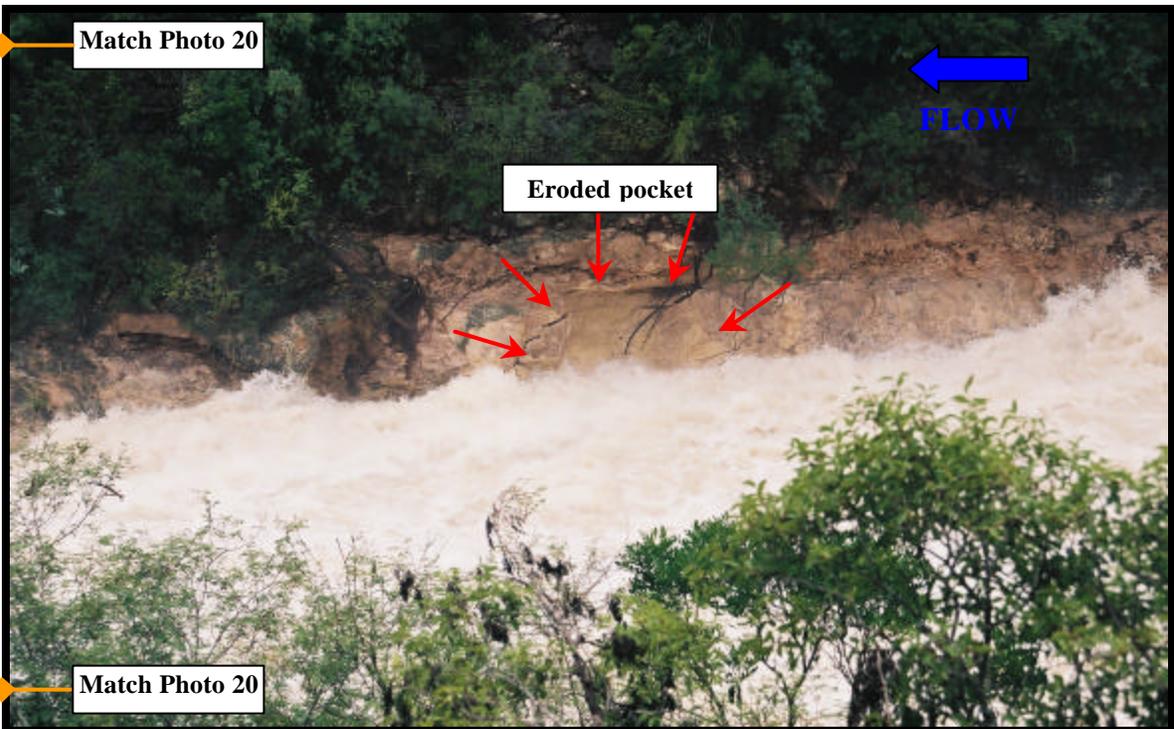
We were able to access the left overbank of the side channel, about 100 to 200 feet downstream of the lip of the emergency spillway. The flow condition was extremely turbulent and was supercritical. There appeared to be active erosion and scour along the right (opposite) bank. **(Photos 19 and 20)**

**Photo 19** View of side channel, looking from left overbank. Note the newly eroded pocket in the opposite bank. (Friday, July 5<sup>th</sup>)
