# Lake Medina Dam

## Dam Safety Inspection Report

Site Inspections on July 5 and July 6, 2002  
for the

Texas Natural Resource Conservation Commission

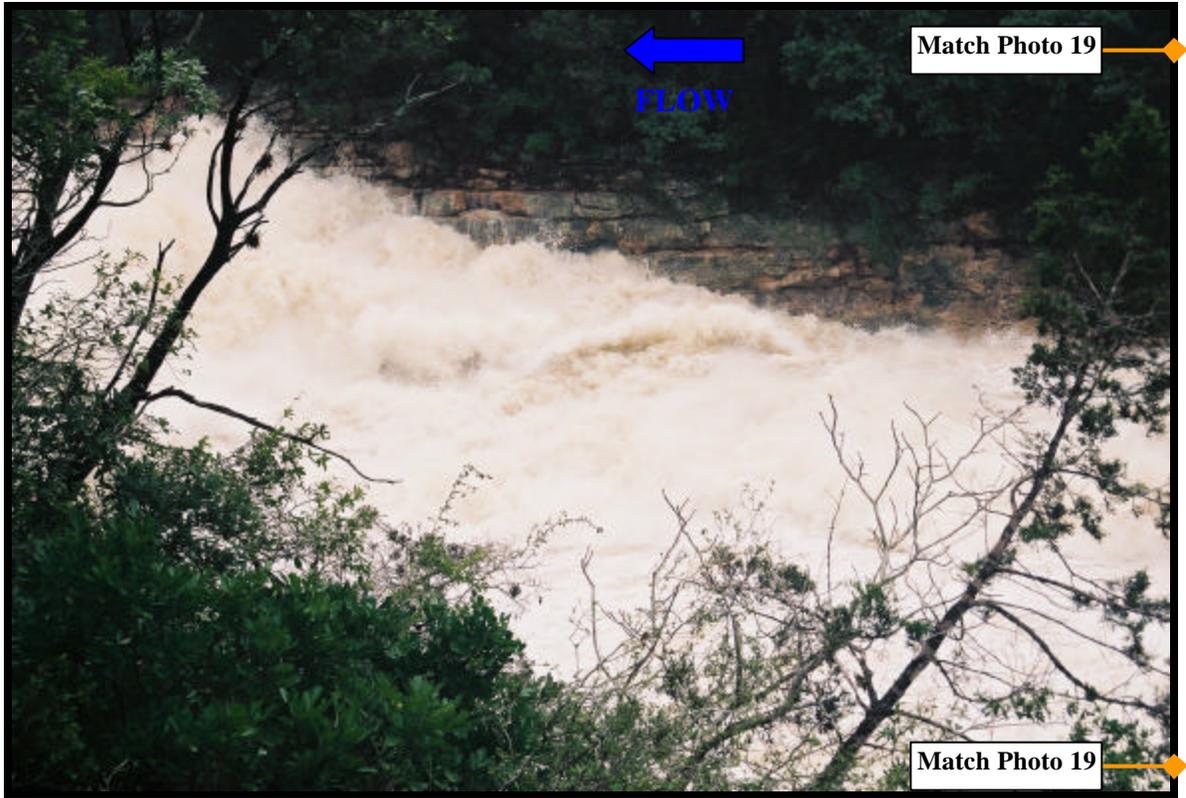
We were able to access the left overbank of the side channel, about 100 to 200 feet downstream of the lip of the emergency spillway. The flow condition was extremely turbulent and was supercritical. There appeared to be active erosion and scour along the right (opposite) bank. **(Photos 19 and 20)**

**Photo 20** View of side channel, looking from left overbank. (Friday, July 5<sup>th</sup>)

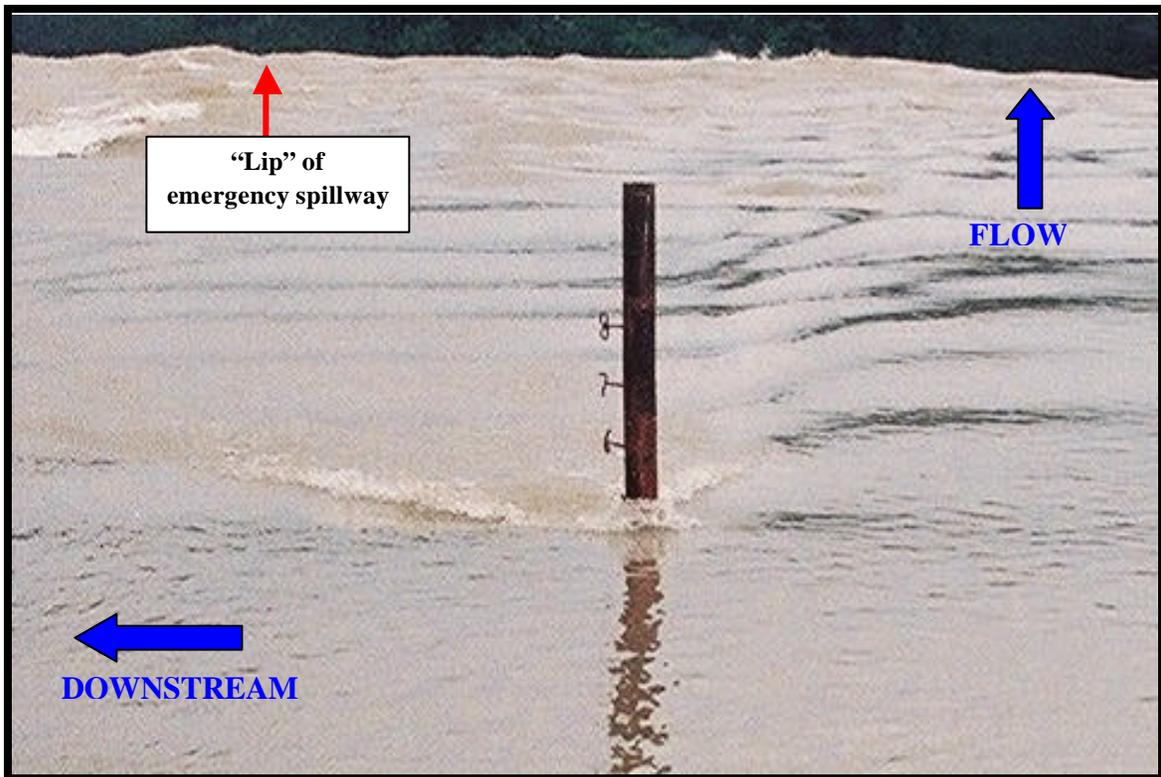
**Photo 21** View of staff gage, looking right. (Saturday, July 6<sup>th</sup>)

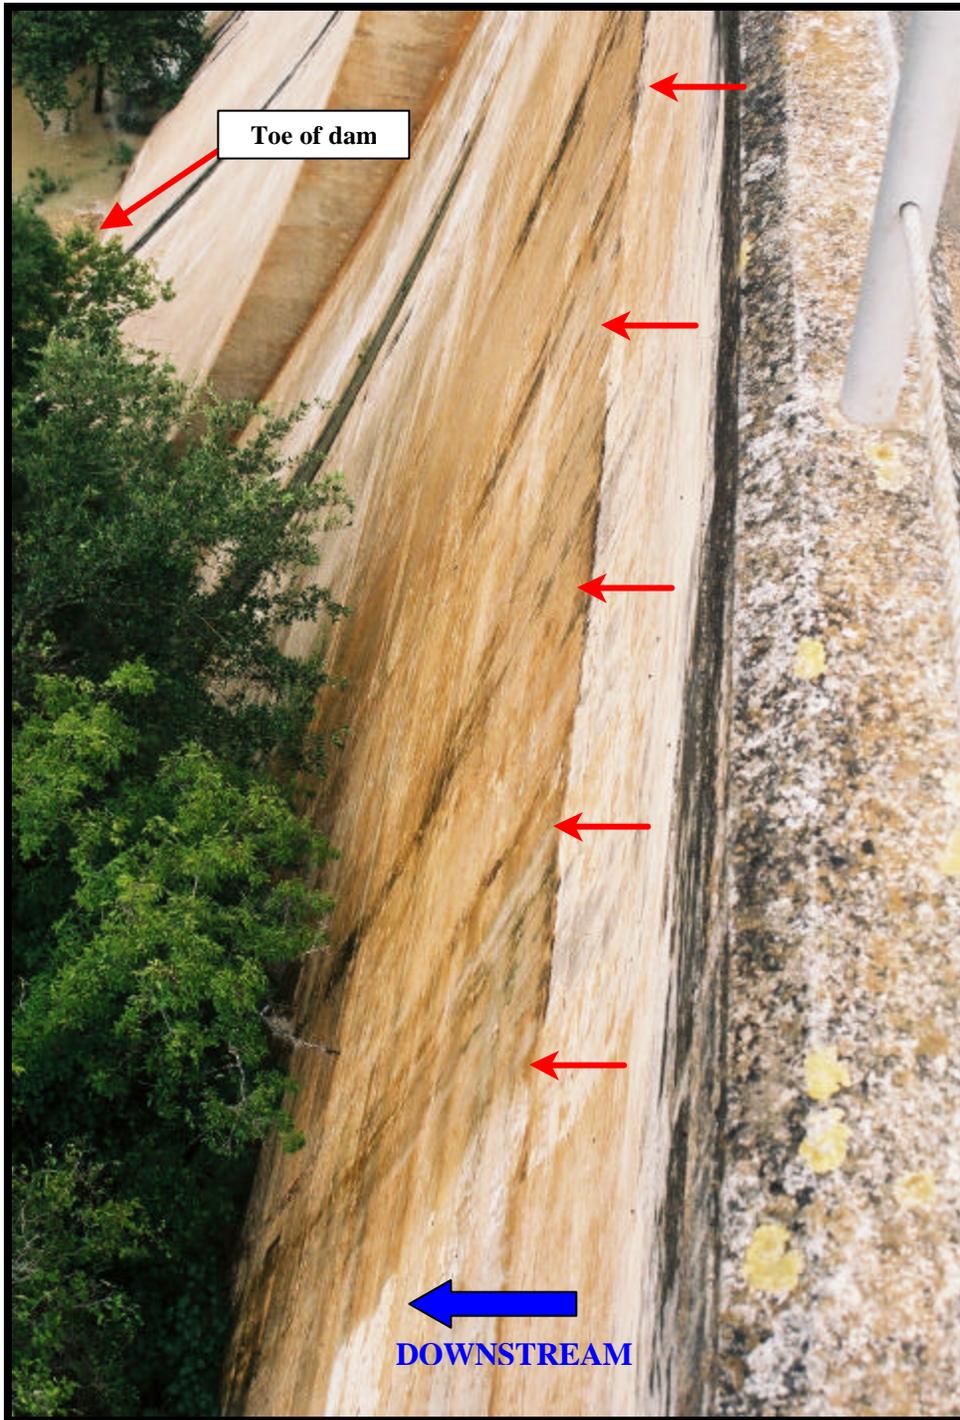
2. We observed a damp section along the downstream face of this section that we felt was evidence that a continuous line of seepage had exited along roughly a 100-foot long section of the highest horizontal construction joint. **(Photo 22)** We did not observe this seepage on Friday or on Saturday, so we assumed the seepage appeared in conjunction with the reservoir peak during the night and disappeared as the reservoir level receded before we were on site on Saturday.

**Photo 22** View of concrete gravity section-left abutment, looking right. Note the dampened section along a horizontal line. (Saturday, July 6<sup>th</sup>)

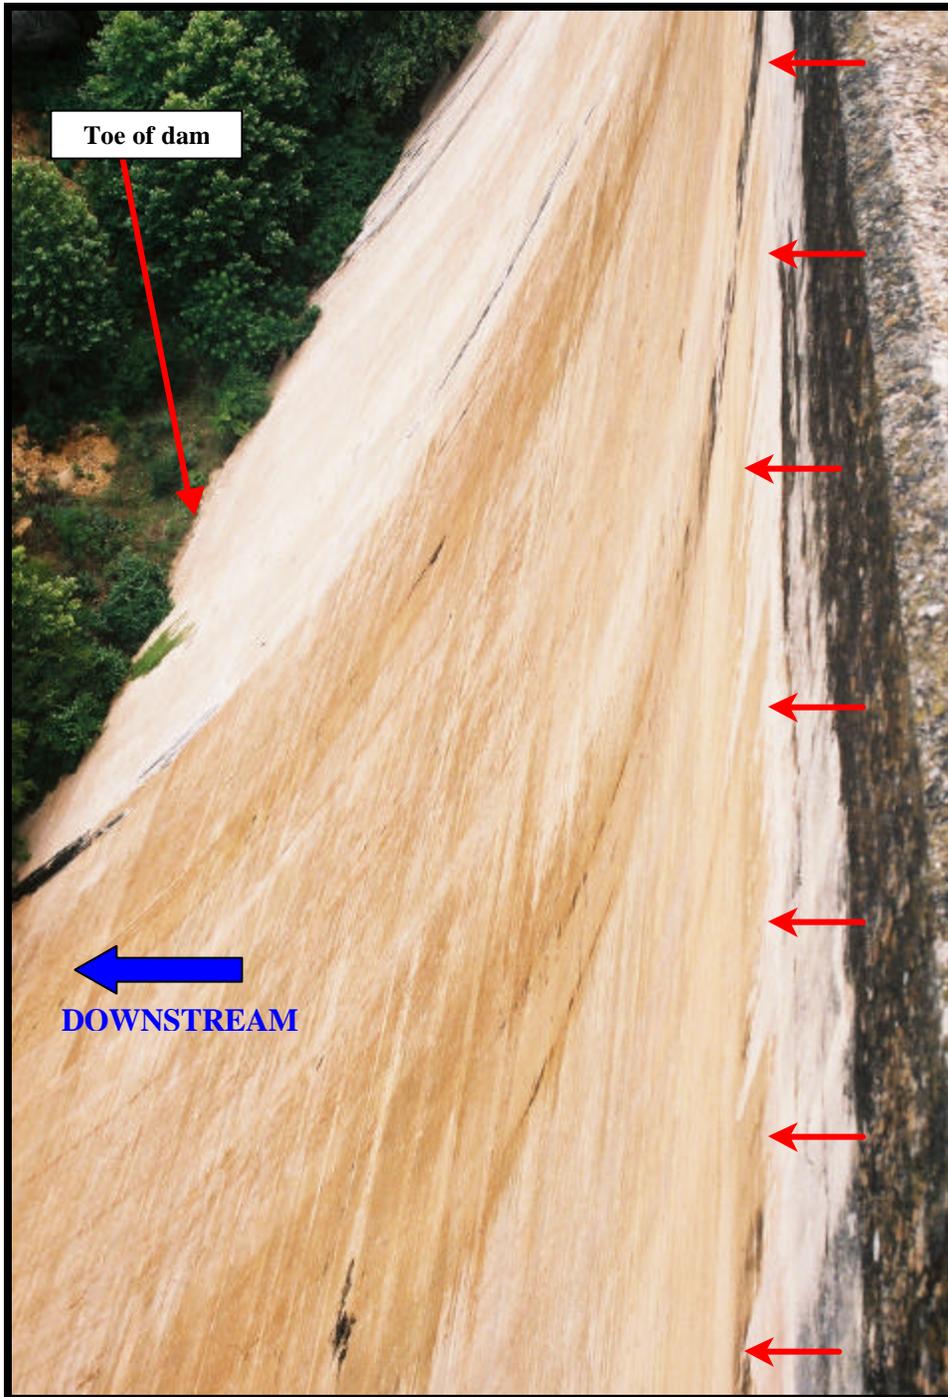
2. We observed a damp section along the downstream face of this section that we felt was evidence that a continuous line of seepage had exited along roughly a 200-foot long section of the highest horizontal construction joint. **(Photo 23)** We did not observe this seepage on Friday or on Saturday, so we assumed the seepage appeared in conjunction with the reservoir peak during the night and disappeared as the reservoir receded before we were on site on Saturday.

**Photo 23** View of concrete gravity section-river, looking right. Note the dampened section along a horizontal line. (Saturday, July 6<sup>th</sup>)

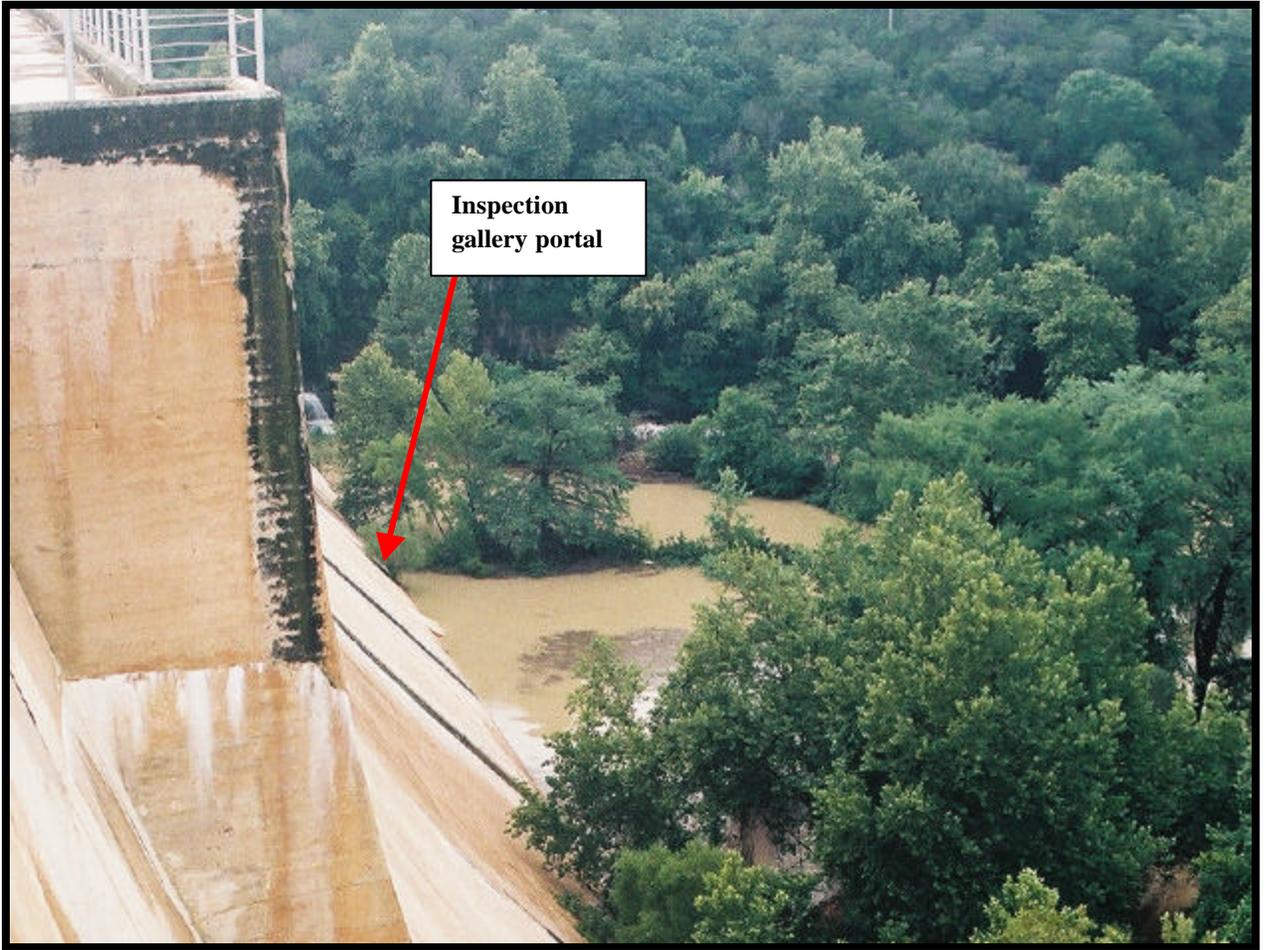
3. The tailwater level was several feet higher than we observed on Friday. From our vantage point on the crest, it appeared that the tailwater level was only several feet up on the bulkhead door for the inspection gallery. **(Photo 24)**

**Photo 24** View of concrete gravity section-river, looking left and downstream. Note the tailwater level is just below the inspection gallery portal. (Saturday, July 6<sup>th</sup>)

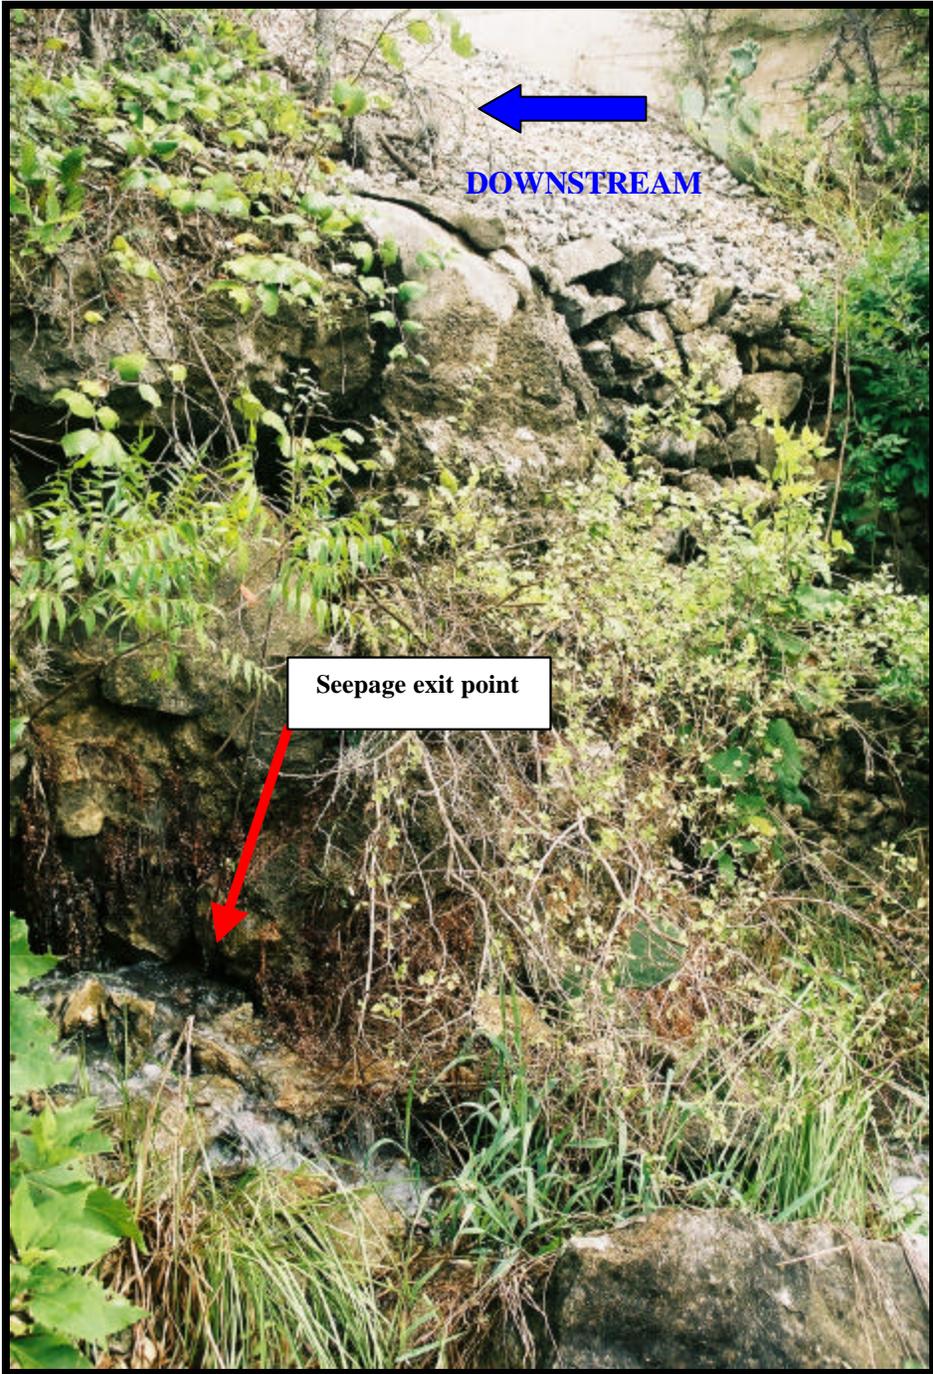
3. In accessing several areas of the abutment, along the toe of the dam, we also noticed another seepage discharge from the rock outcropping near the first seepage area. Because of the heavy undergrowth, we could not determine if this second seepage area was existing or new. **(Photos 25 and 26)**

**Photo 25** View of foundation seepage downstream of toe of dam, looking right.  
(Saturday, July 6<sup>th</sup>)

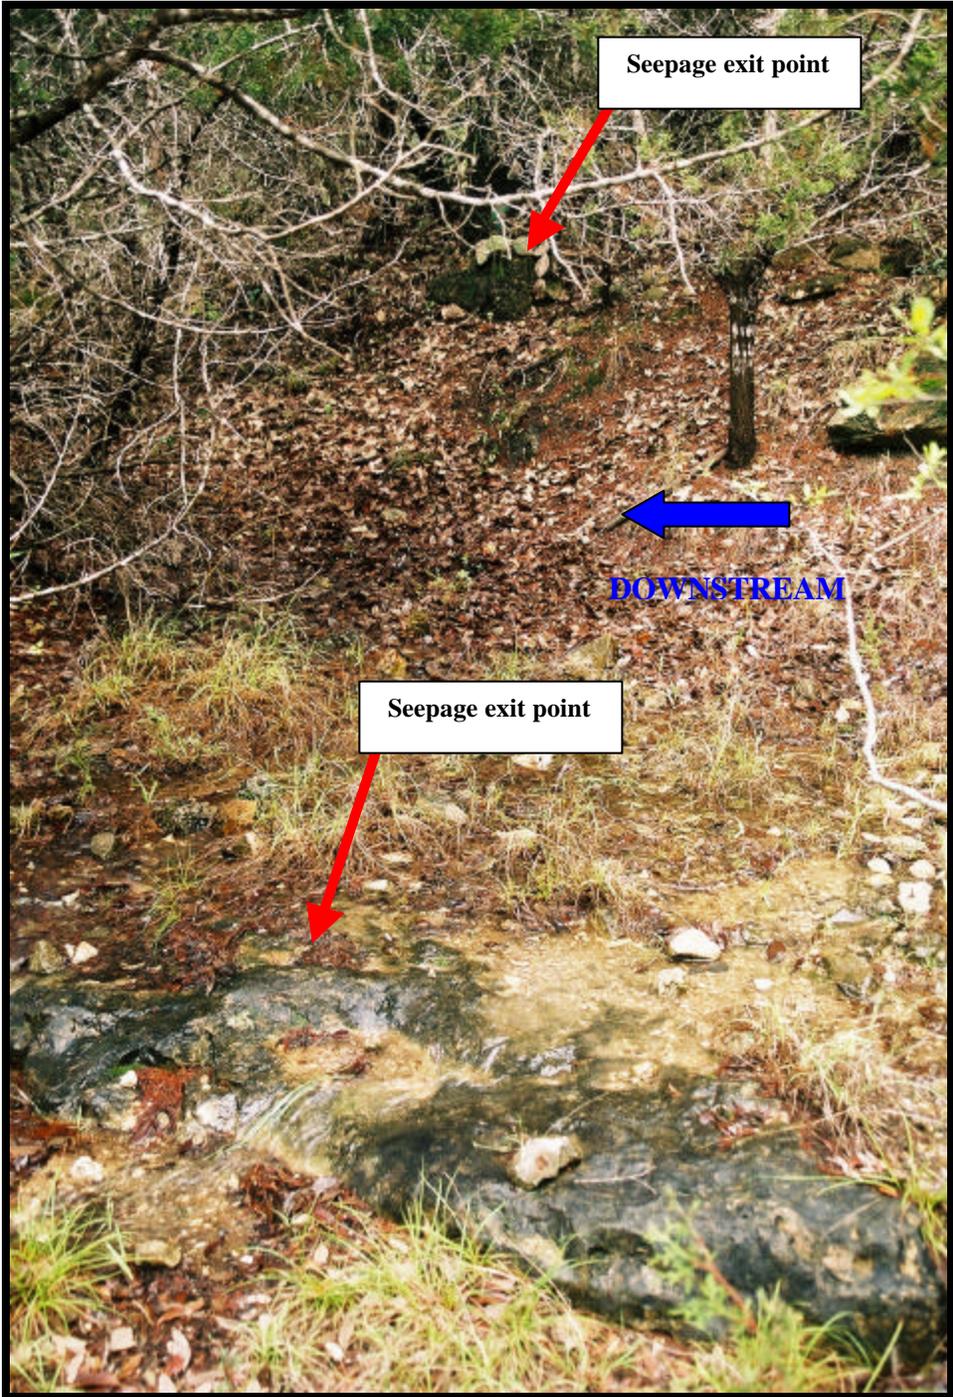
**Photo 26** View of foundation seepage downstream of the dam. (Saturday, July 6<sup>th</sup>)

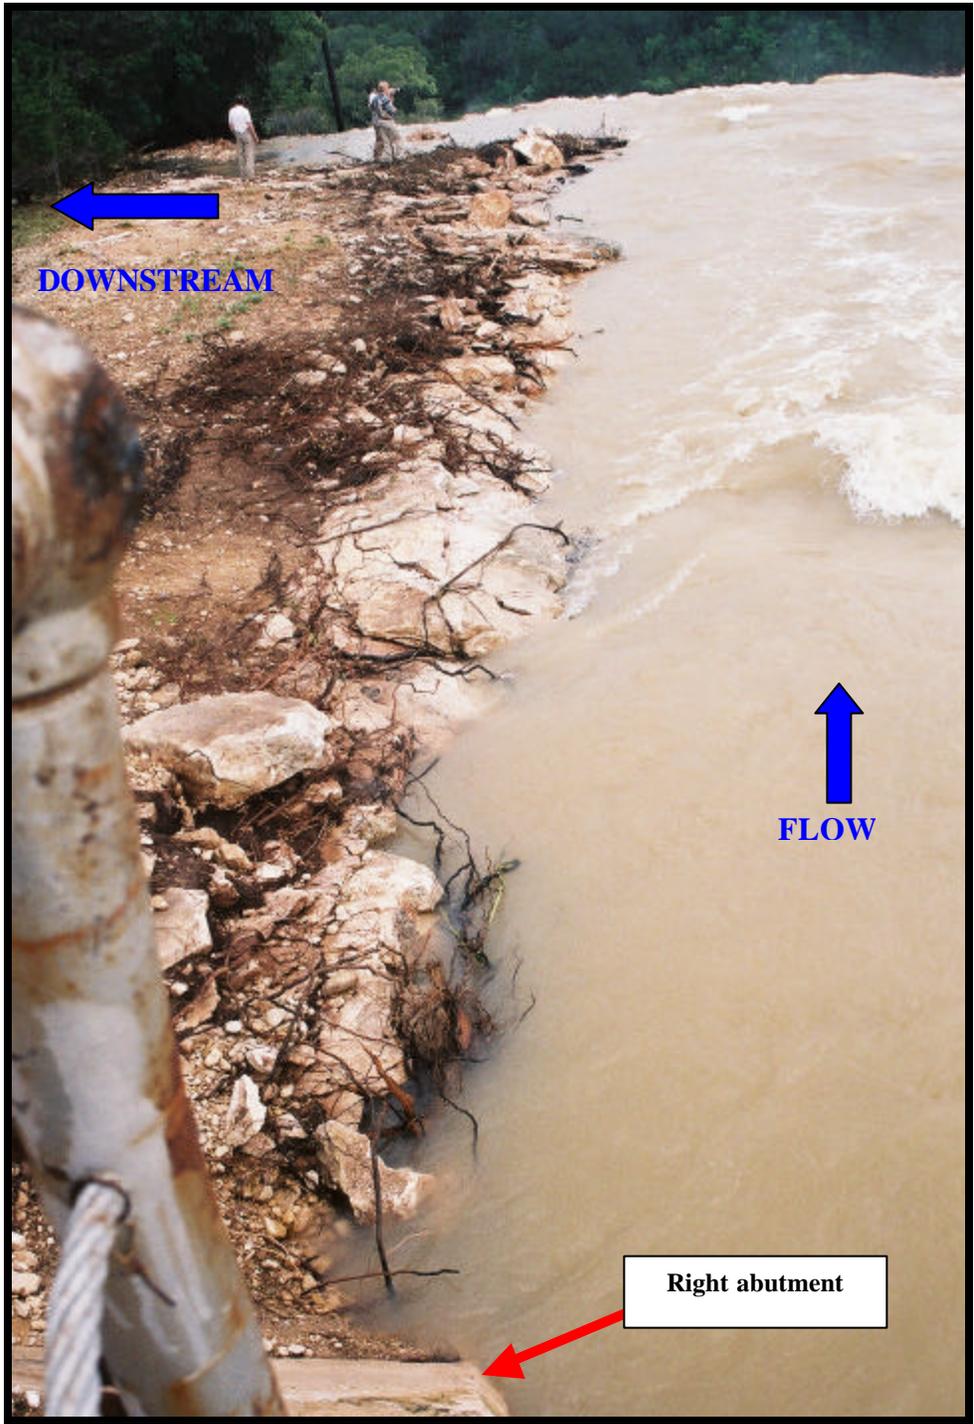
4. With the reservoir level having receded to about the same level as when the COE performed its Friday morning inspection, the hydraulic conditions were not as severe as what we observed Friday afternoon, nor as severe as apparently occurred during the night when the reservoir level peaked. The flow depth through the emergency spillway had dropped low enough prior to the Saturday inspection that the flows were within the confines of the emergency spillway channel and erosion around the end of the gravity section had stopped. **(Photo 27)**

5. The fill around the right end of the gravity section had eroded some 10 feet into the overbank, exposing at least five (5) feet of the end of the structure. The fill had eroded down to the top of the rock formation, which was about 5 to 7 feet below the crest of the dam. **(Photo 27)**

**Photo 27** View of erosion along right abutment, looking right. (Saturday, July 6<sup>th</sup>)

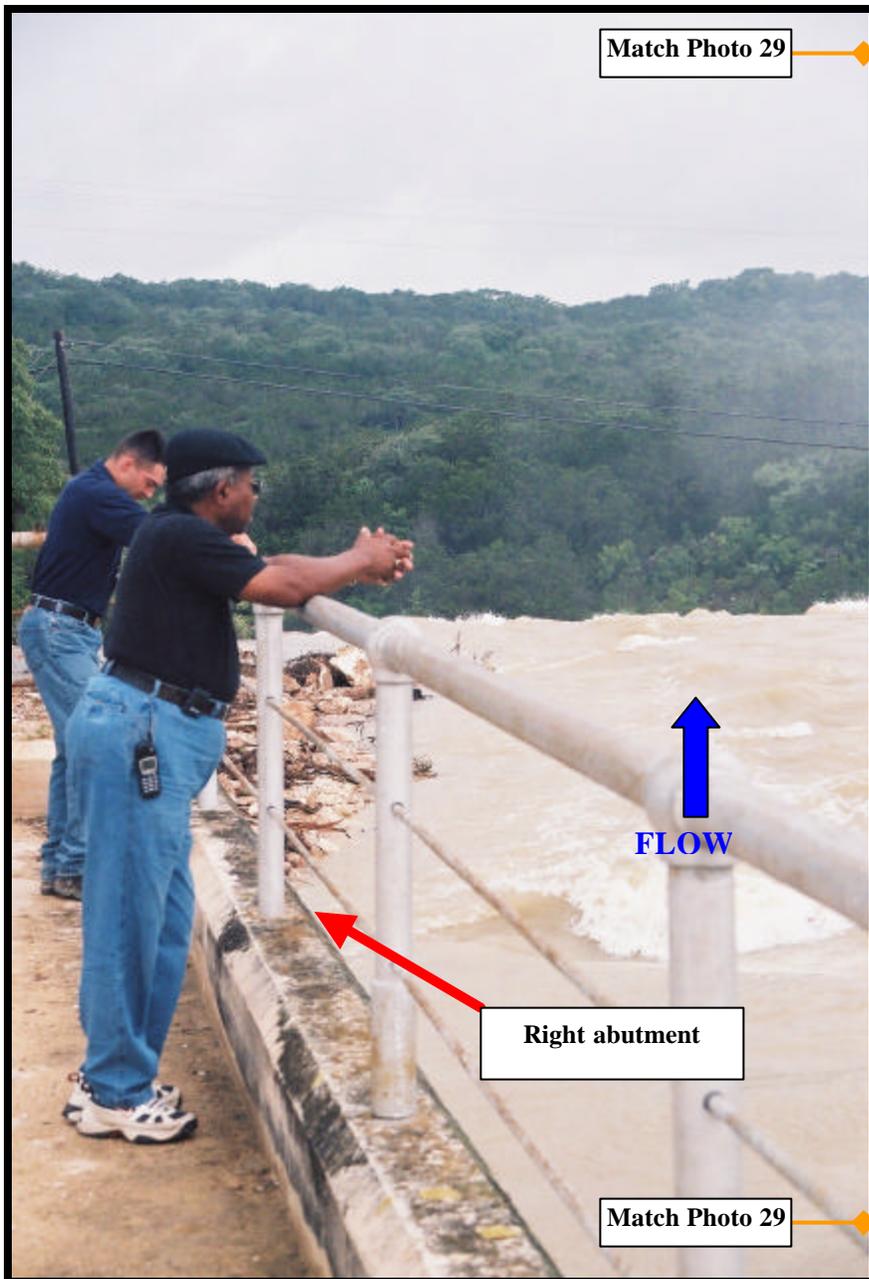
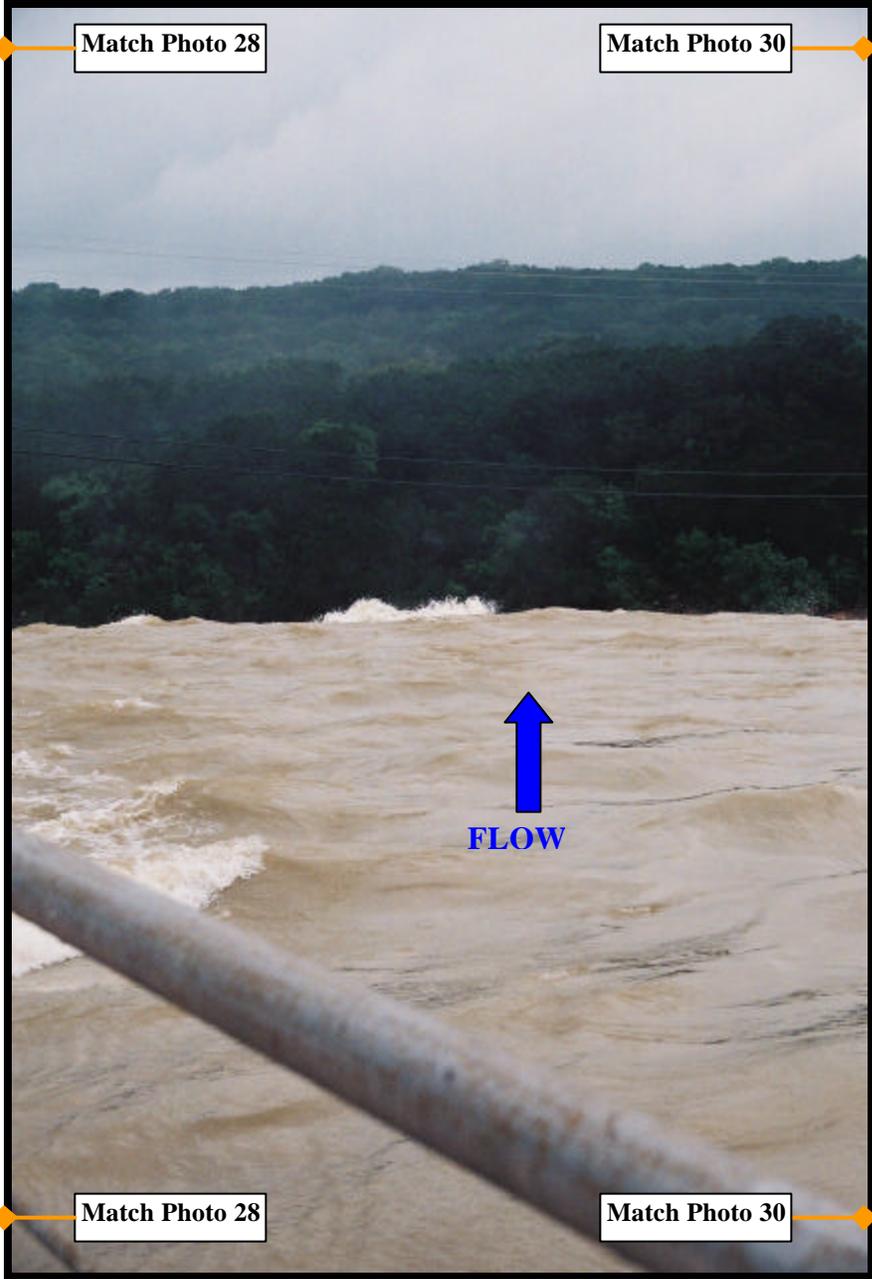
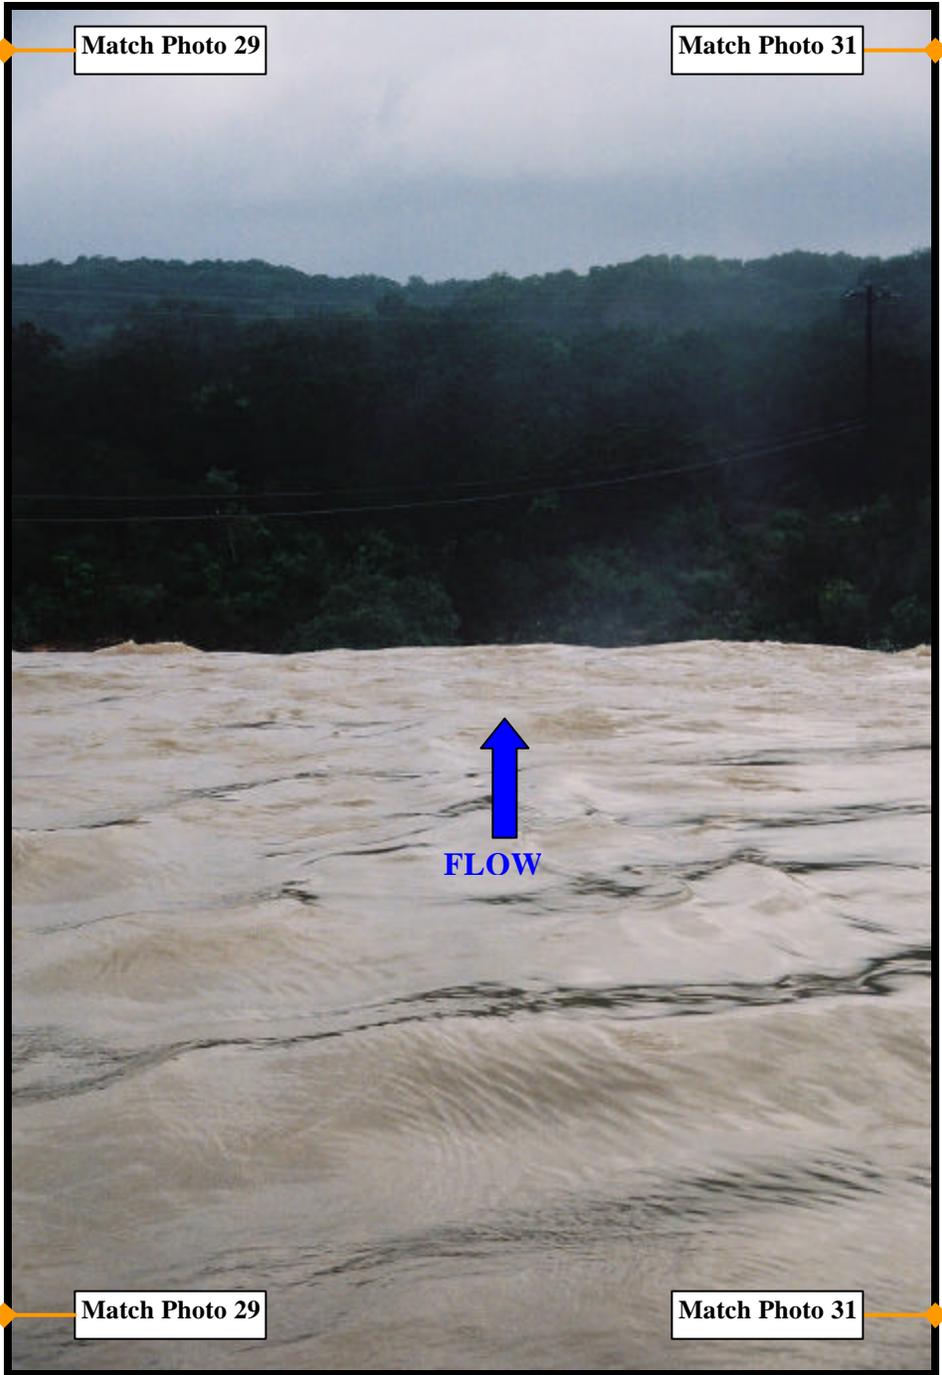
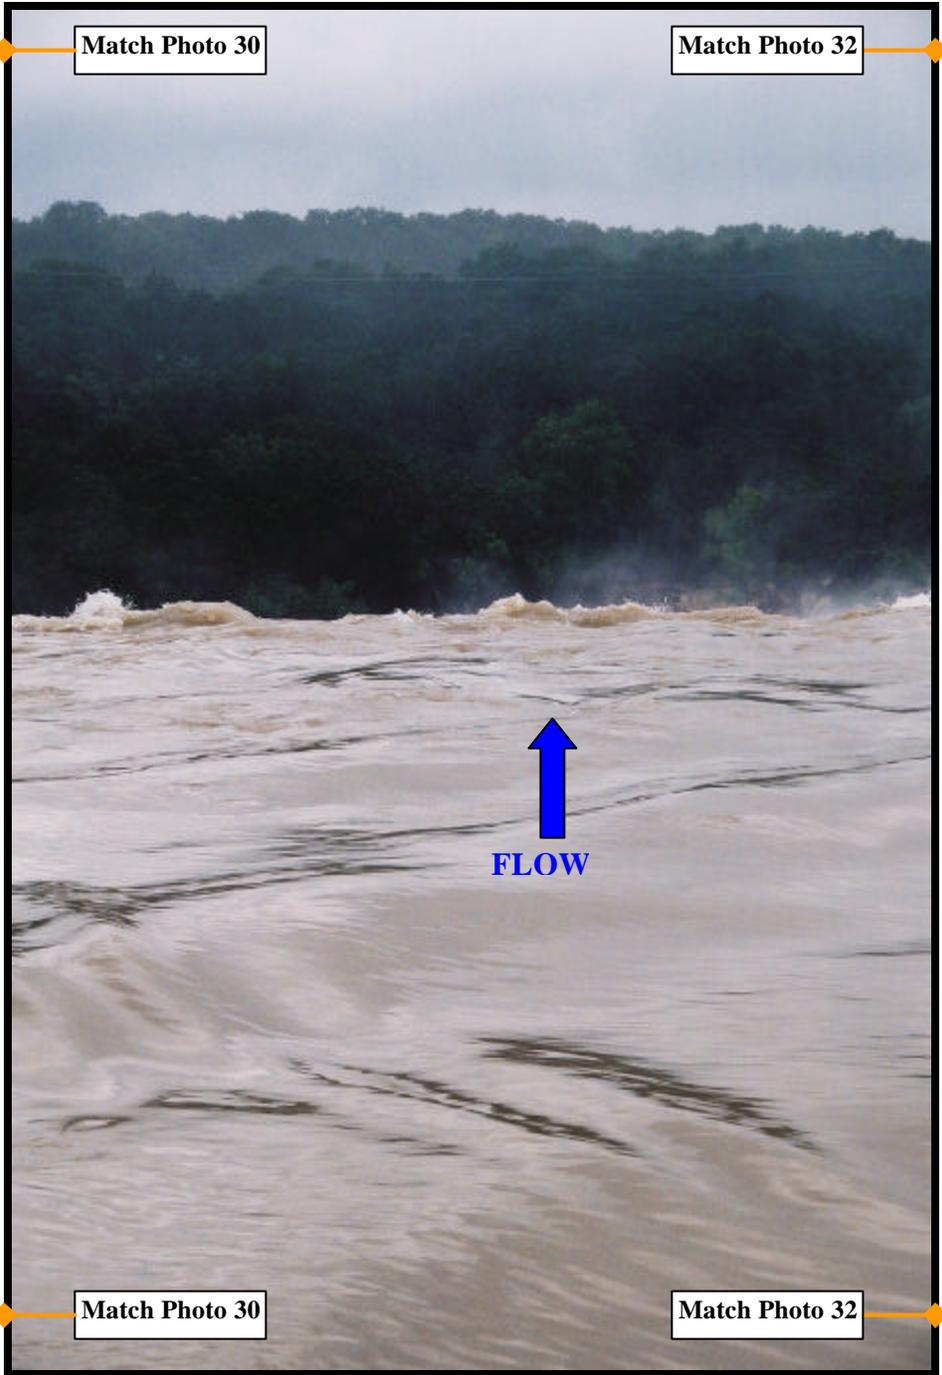
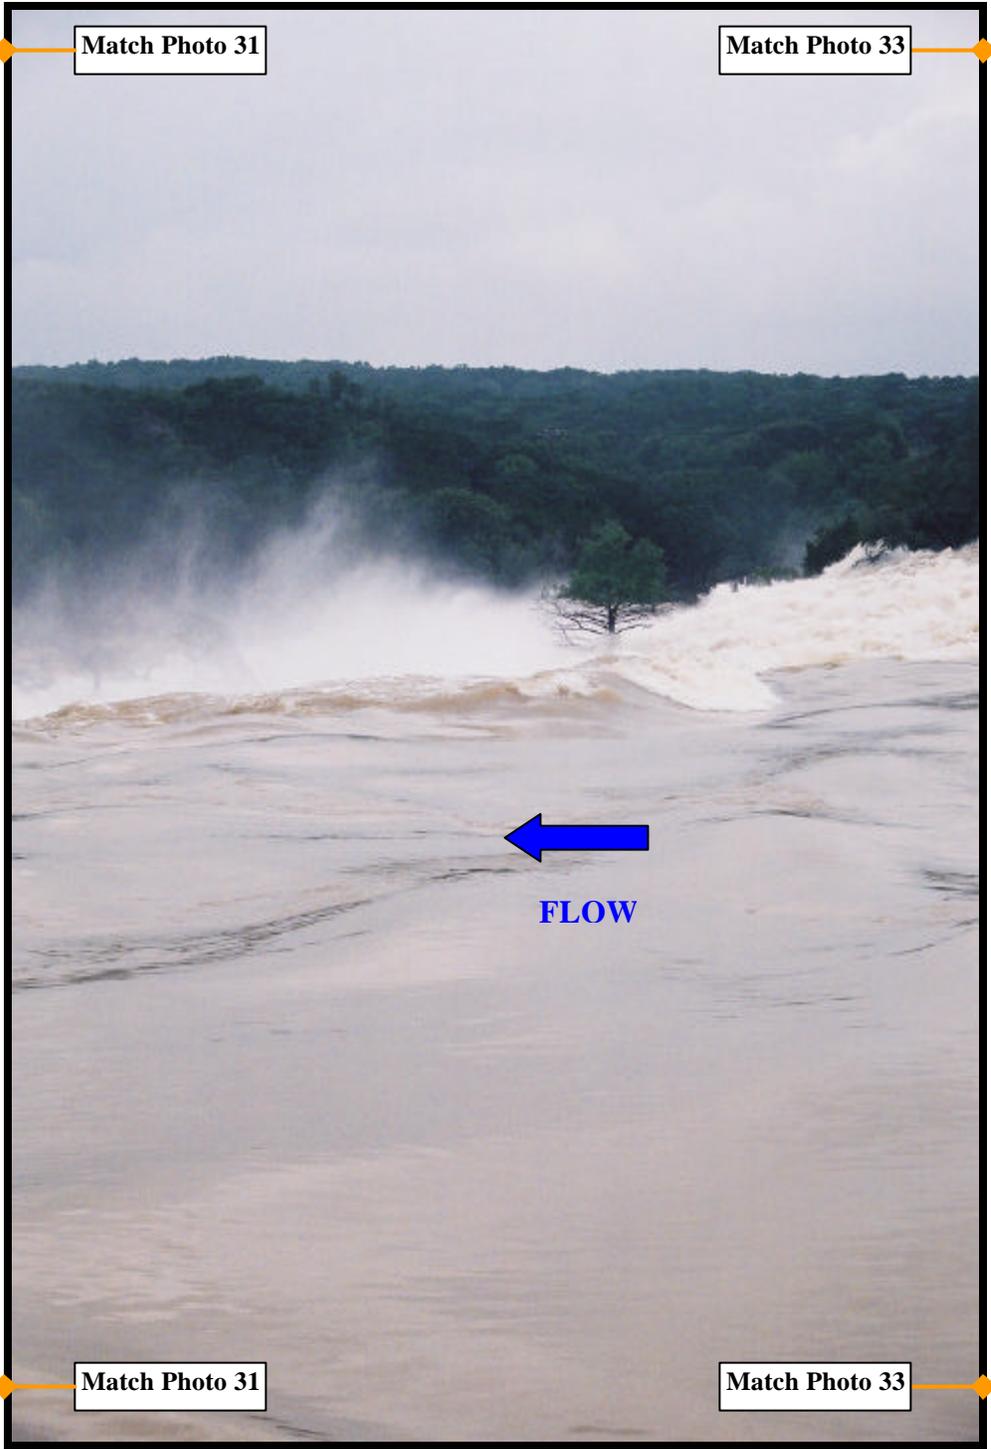
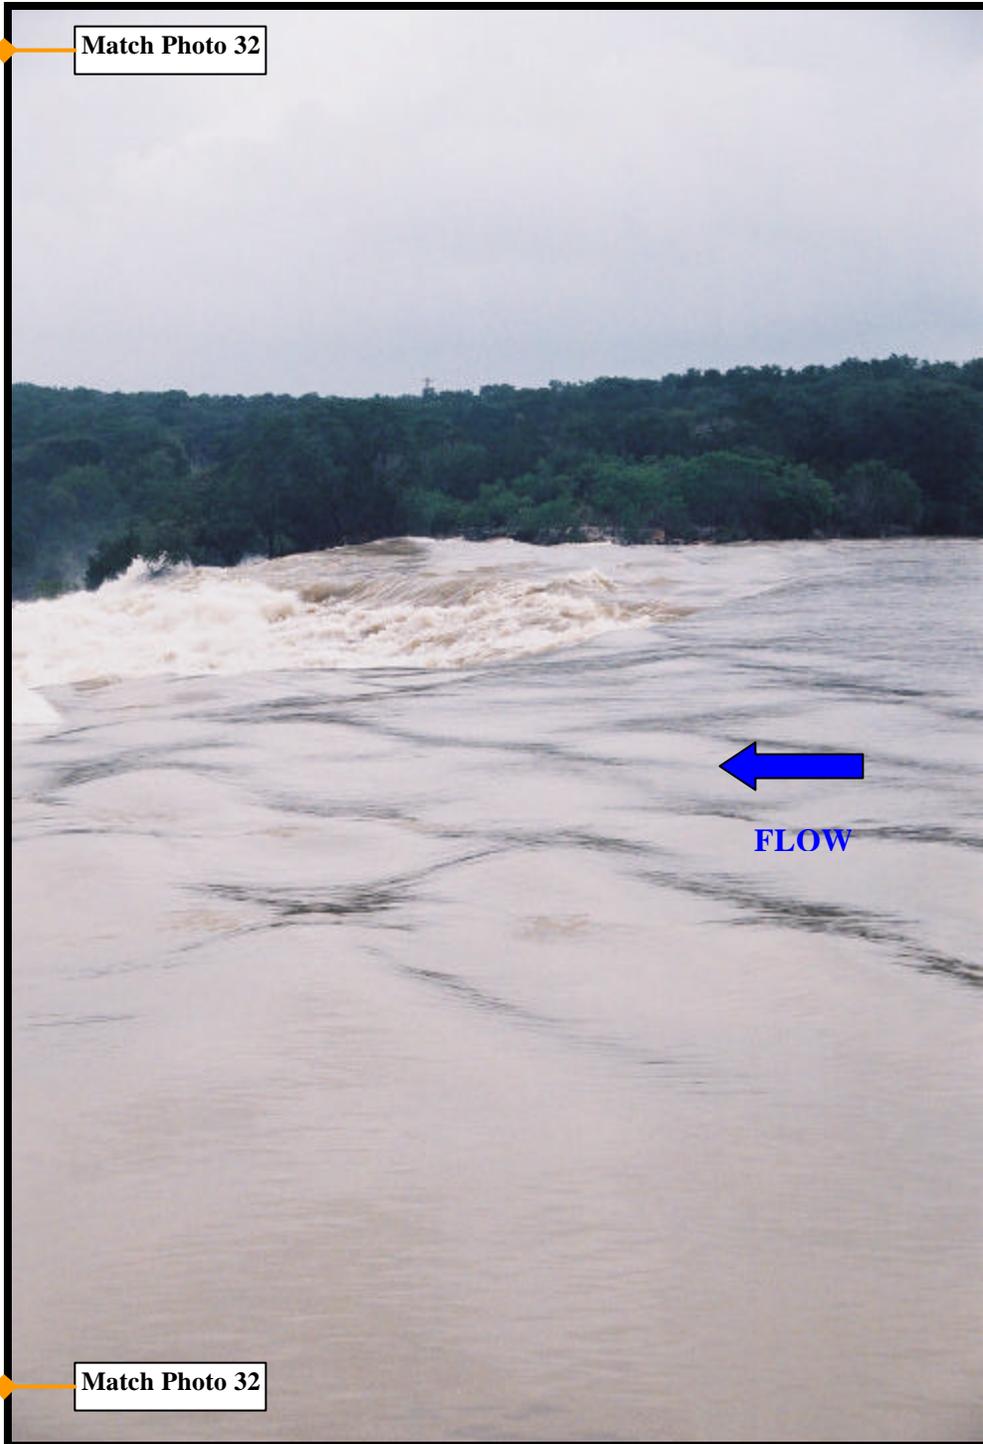
undergoing active erosion. We observed that at least one tree behind and below the right end of the dam had been lost since the Friday afternoon inspection, so we surmised that there was some loss of foundation rock below the "lip" of the control section. We could not determine if the "lip" of the control section had migrated closer to the right end of the gravity section. **(Photos 28, 29, 30, 31, 32, and 33, 34)**

**Photo 28** Panoramic view of emergency spillway, looking right. (Saturday, July 6<sup>th</sup>)

Photo 29 Panoramic view of emergency spillway, looking right. (Saturday, July 6<sup>th</sup>)

**Photo 30** Panoramic view of emergency spillway, looking right. (Saturday, July 6<sup>th</sup>)

**Photo 31** Panoramic view of emergency spillway, looking right. (Saturday, July 6<sup>th</sup>)

**Photo 32** Panoramic view of emergency spillway, looking right. (Saturday, July 6<sup>th</sup>)

**Photo 33** Panoramic view of emergency spillway, looking right. (Saturday, July 6<sup>th</sup>)
